Structural Assessment of the Amtrak Under River Tunnels in NYC Inundated by Super Storm Sandy

Executive Summary

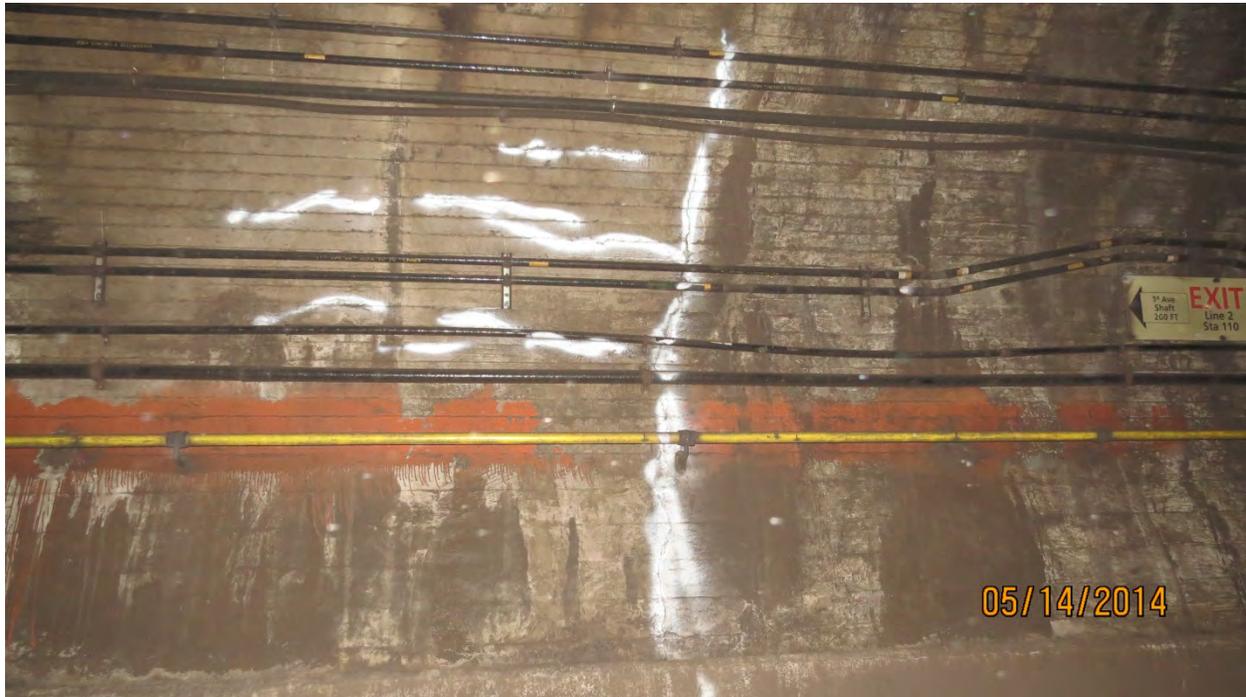
Photo E1: Typical Transverse Moderate Crack up to 1/16" wide, South Wall, Line 2 Station 109+90. Photo Ref. GK07-020, looking South.

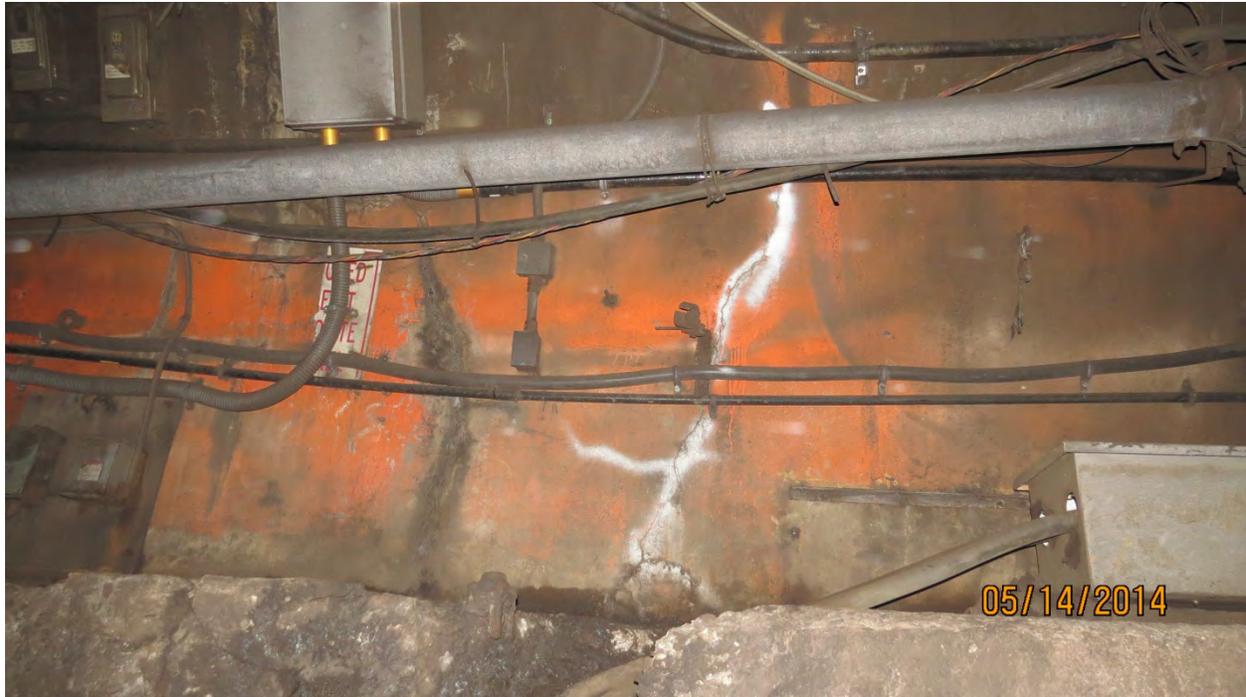
**Photo E2: Transverse Moderate Crack up to 1/8" wide, North Wall, Line 2 Station 108+42.
Photo Ref. GK07-045, looking Begin, North.**

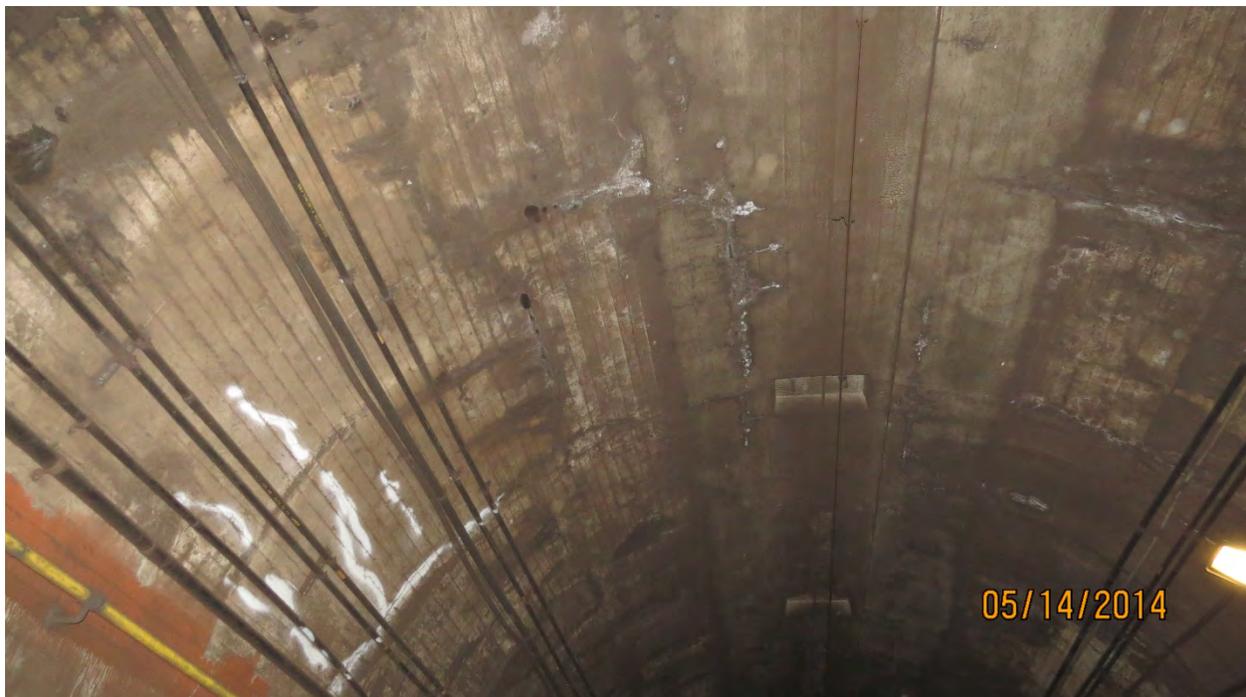
**Photo E3: Longitudinal Moderate Crack with Efflorescence near Crown. Isolated Damp Spots
with Active Moisture on South Wall, Line 2 Station 109+90.
Photo Ref. GK07-023, looking End, Up.**

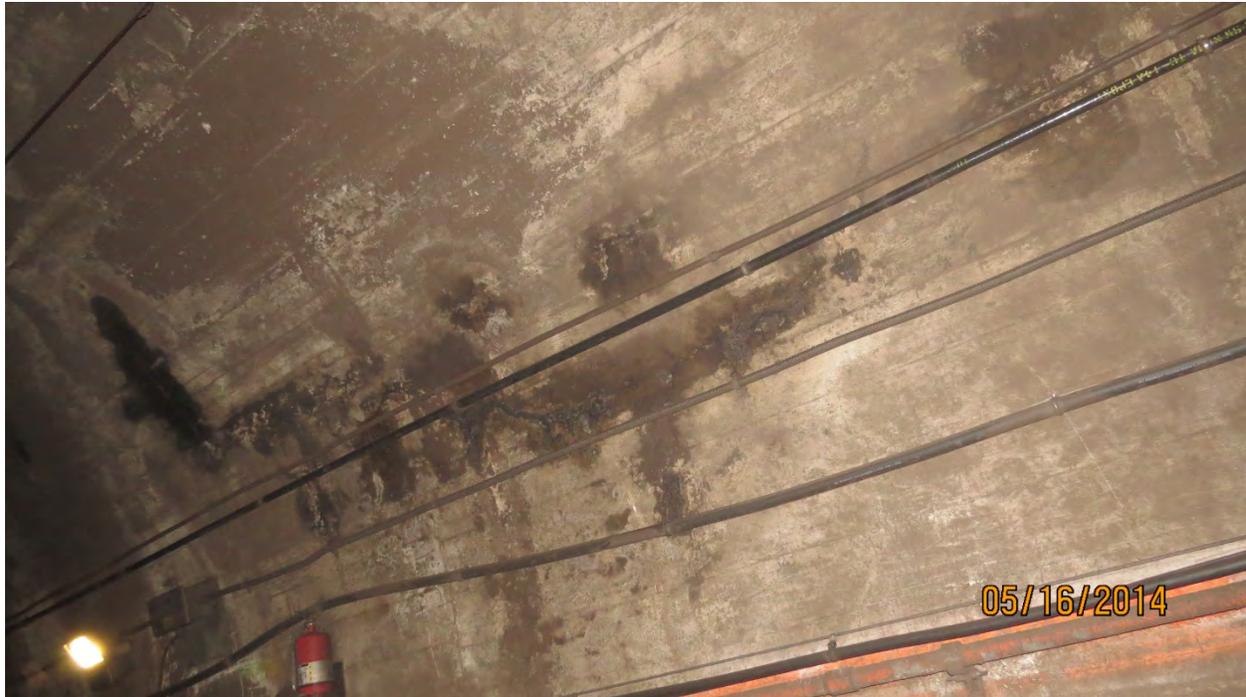
Photo E4: Longitudinal Moderate Crack up to 1/16" wide Staining, Efflorescence and Active Moisture, South Wall, Line 1 Station 88+26. Photo Ref. GK09-033, looking Begin, South.

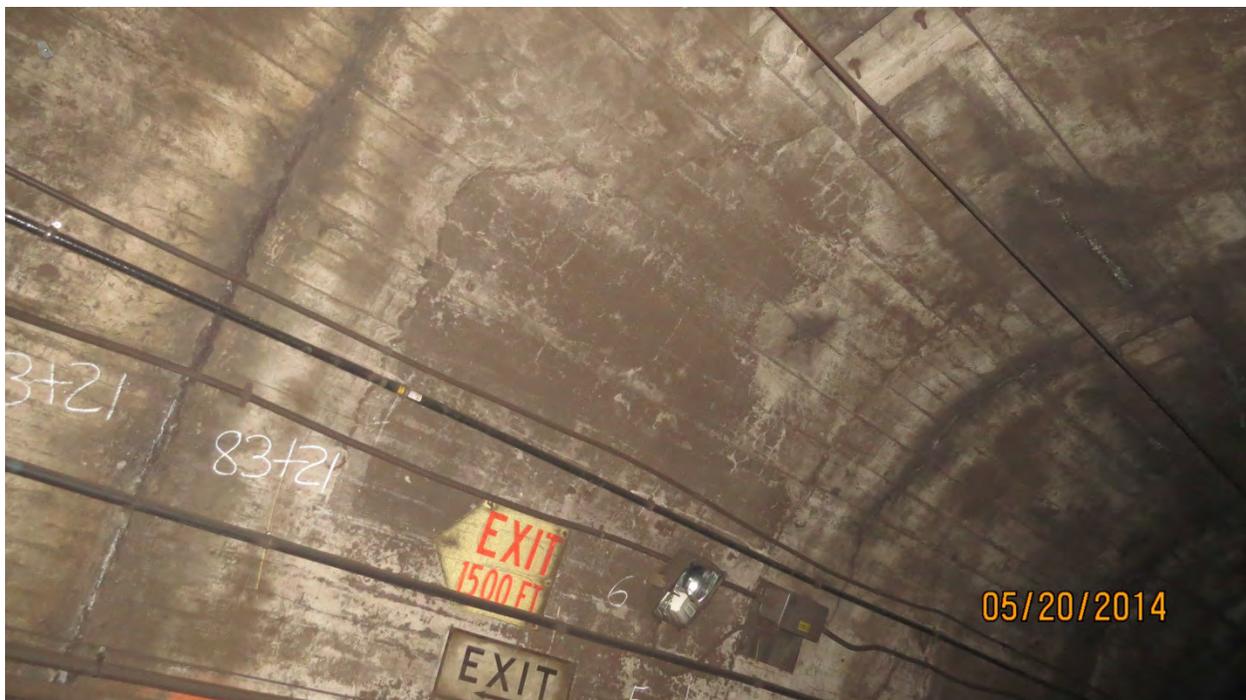
Photo E5: Diagonal Moderate Crack 6' long x up to 1/32" wide near Crown, transitioning to Transverse Moderate Crack, South Wall, Line 1 Station 83+21. Photo Ref. GK11-033, looking End, South.

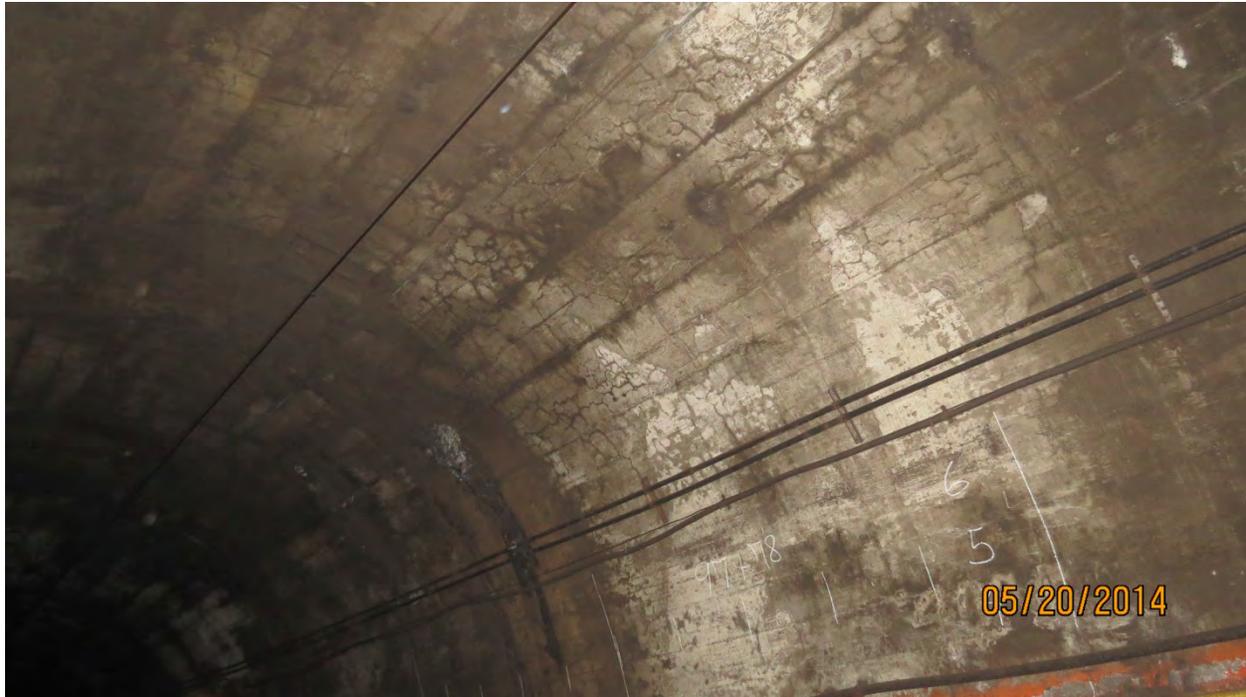
Photo E6: Map Cracking, with cracks up to 1/32", North Wall, Line 1 Station 97+78. Incrustation with Efflorescence and Active Moisture visible in background, at Line 1 Station 97+85. Photo Ref. GK11-083, looking End, North.

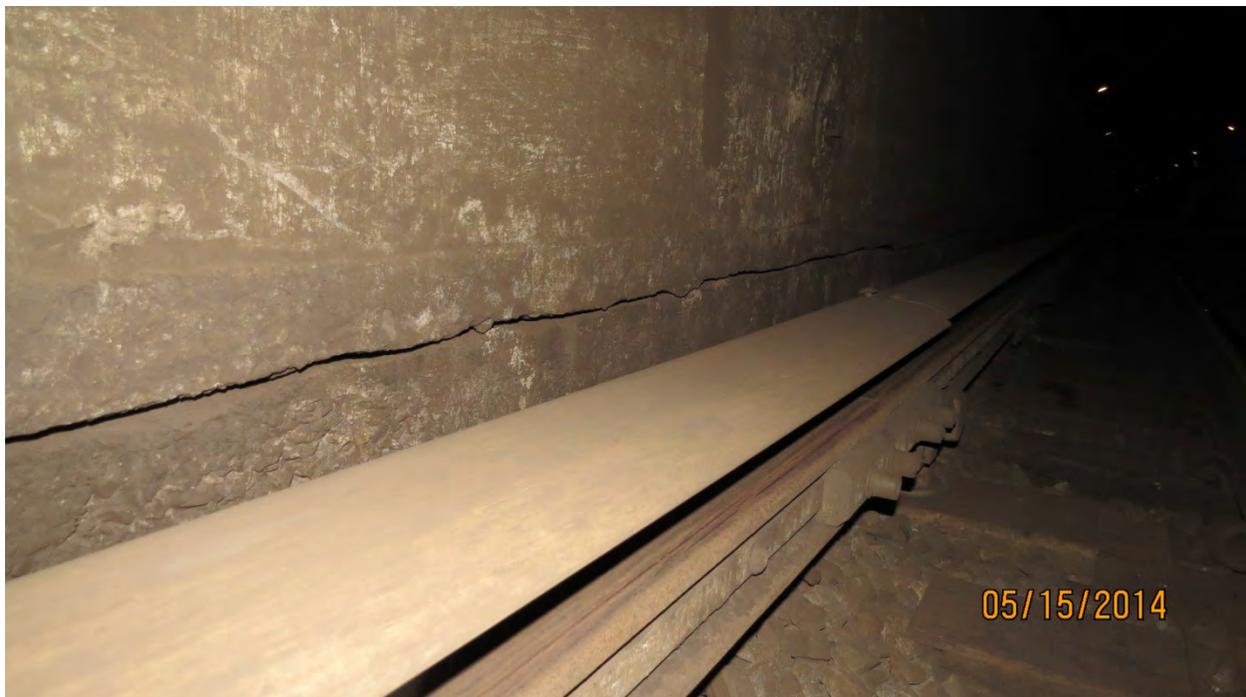
Photo E7: Longitudinal Severe Crack over 500' long x up to 1/2" wide near base of North Bench Wall, Line 1 Stations 100+00 to 105+20. Photo Ref. GK08-062, looking Begin, North.

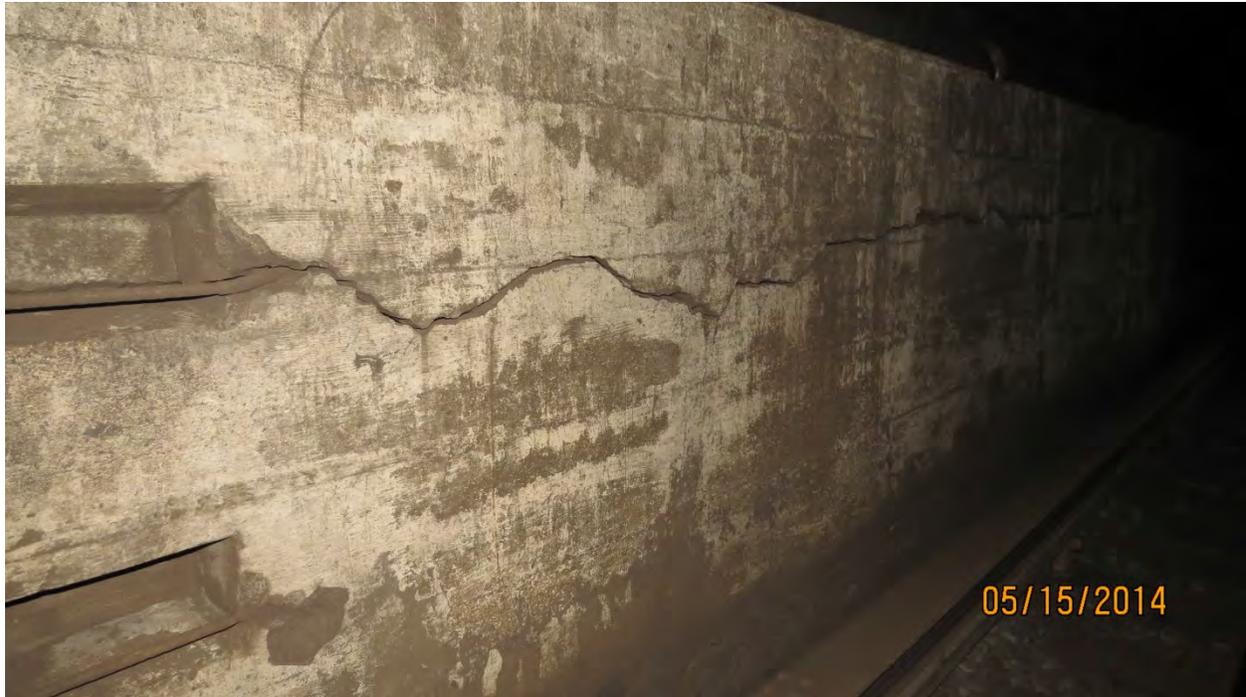
Photo E8: Longitudinal Severe Crack 25' long x up to 3/4" wide, North Bench Wall, Line 1 Station 105+20. Photo Ref. GK08-058, looking Begin, North.

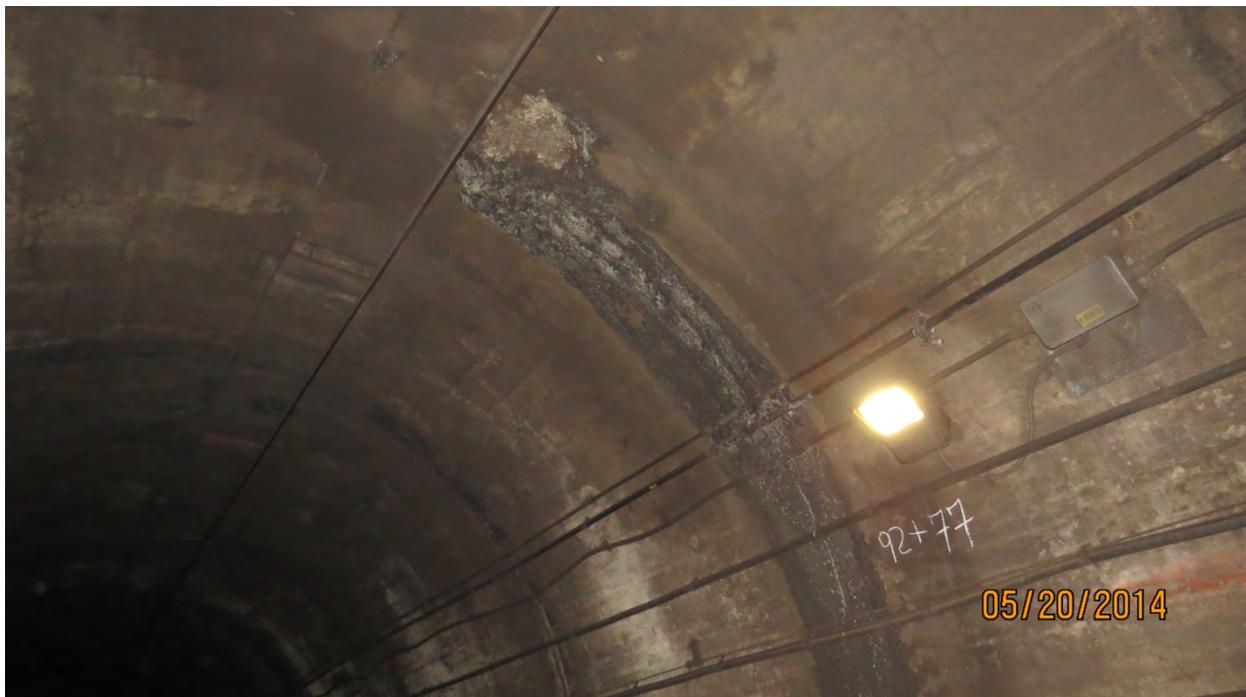
Photo E9: Severe Spall 2' long x 1.5' wide x up to 4" to 5" deep near Crown, South Wall, Line 1 Station 92+77. Incrustation, Stalactites, Efflorescence and Active Moisture with inflow of 15 drops per minute adjacent to Spall. Photo Ref. GK11-055, looking Begin, South.

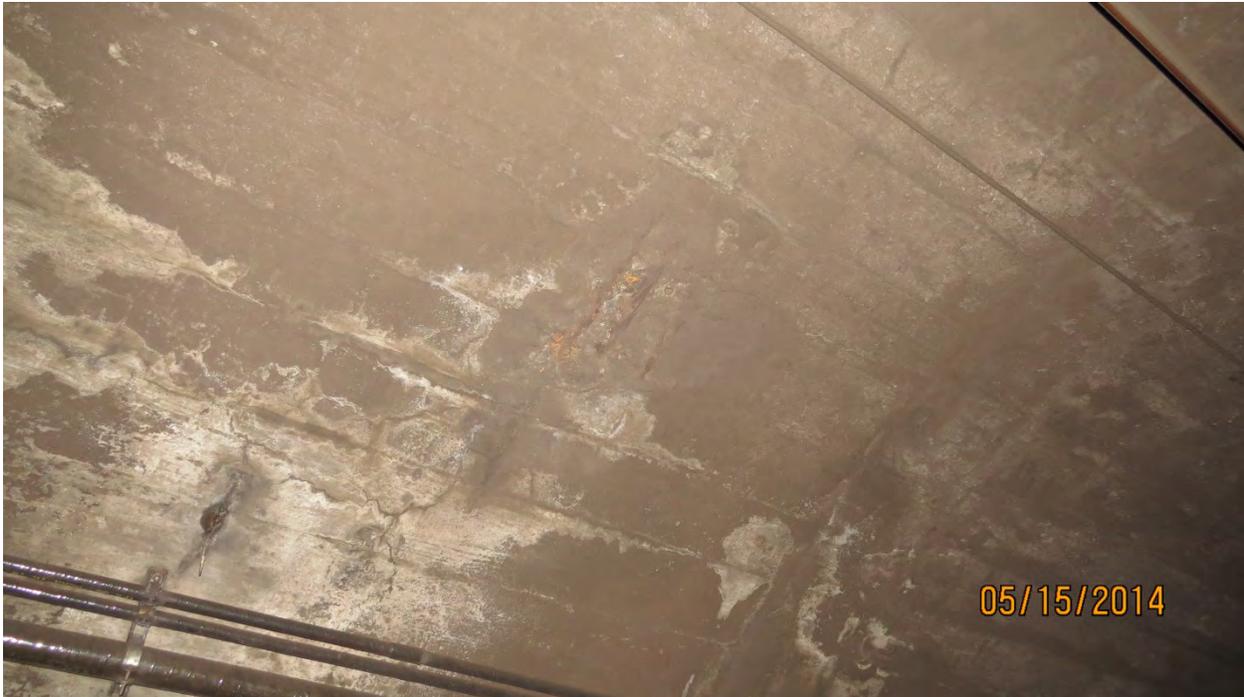
Photo E10: Severe Spall 6' long x 12" wide x 1" deep at 10:15 position with exposed steel, North Wall, Line 1 Station 104+38. Stalactite and point of Active Moisture also visible. Photo Ref. GK08-067, looking Begin, North.

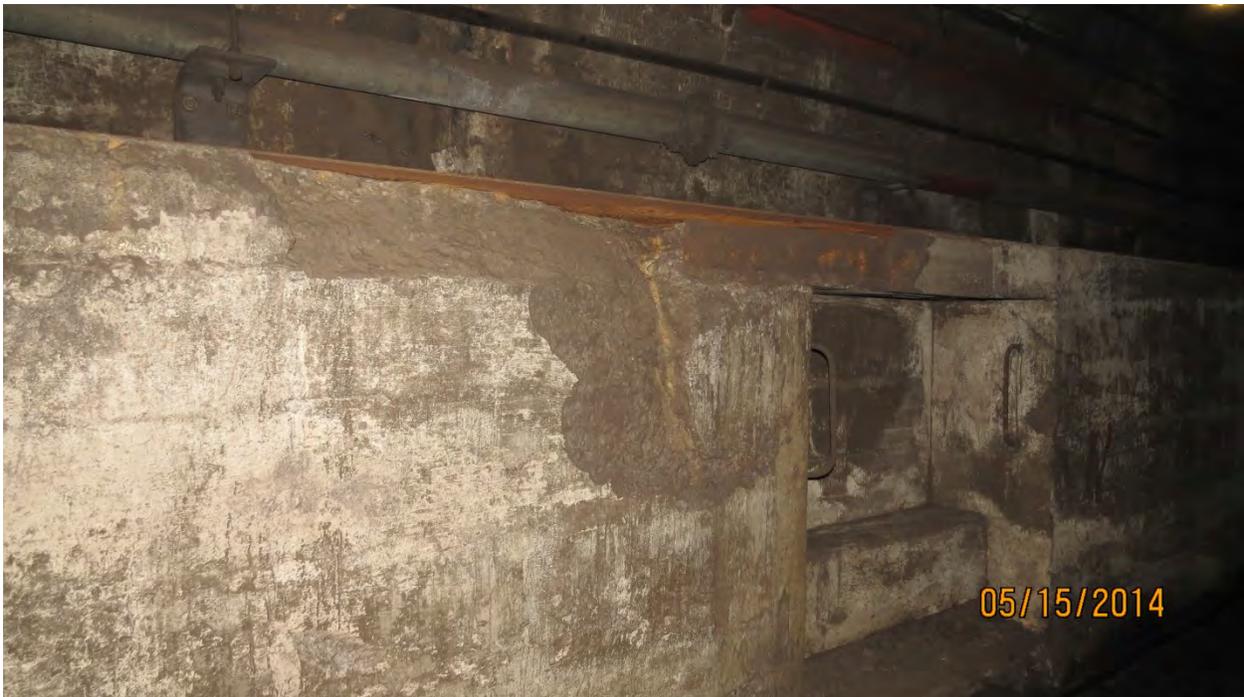
Photo E11: Typical Severe Spall with exposed steel adjacent to manhole refuge niche, South Bench Wall near Line 1 Station 100+77. A steel plate was installed to cover missing concrete along the top of bench walking surface. Photo Ref. GK08-081, looking End, South.

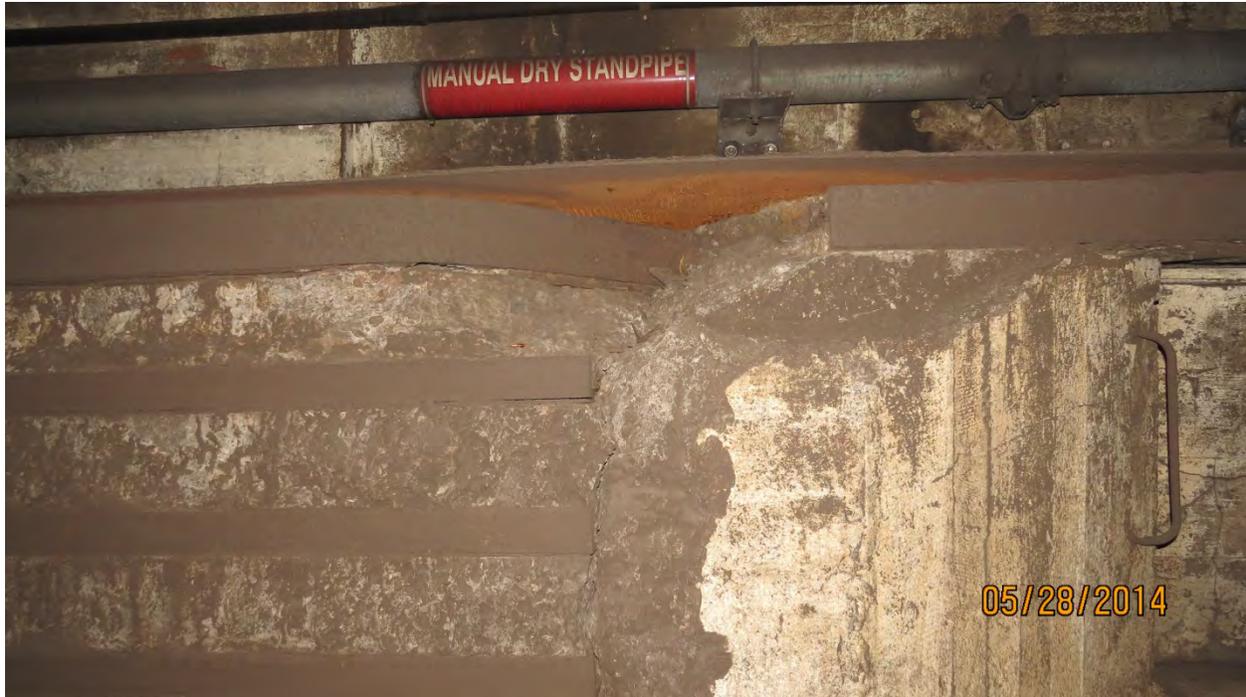
Photo E12: Typical Severe Spall with exposed steel adjacent to manhole refuge niche, North Bench Wall near Line 2 Station 86+14. A steel plate was installed to cover missing concrete along the top of bench walking surface. Photo Ref. GK12-039, looking North.

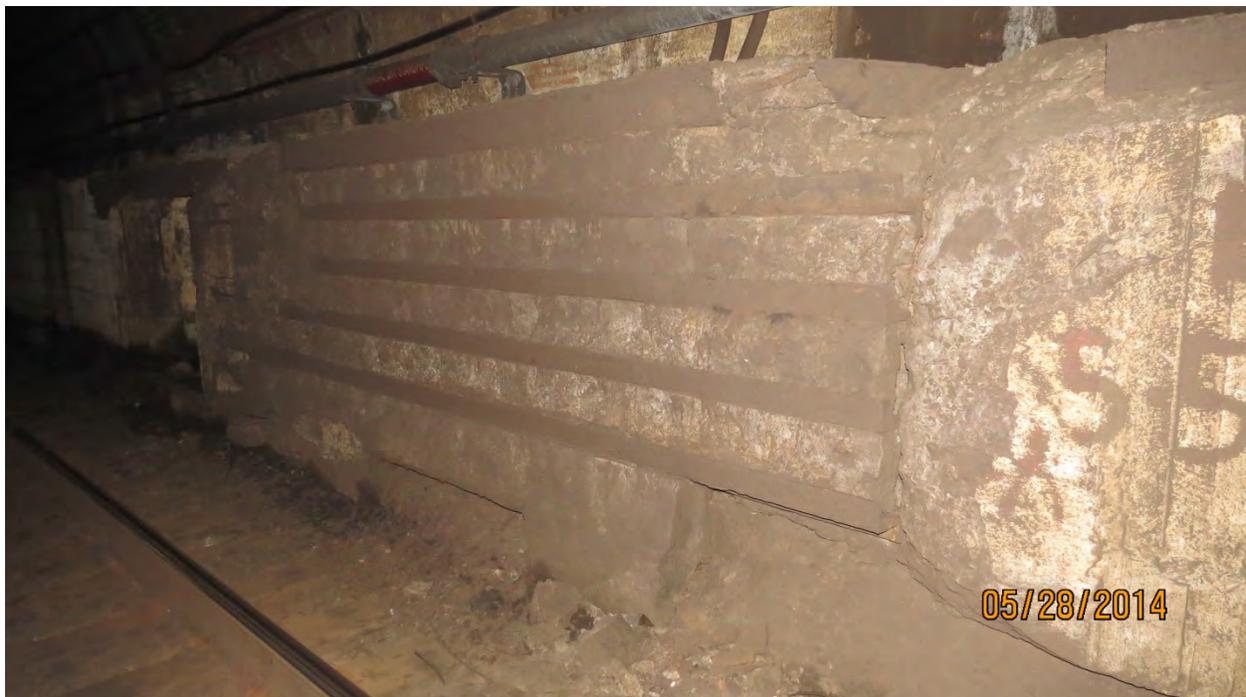
Photo E13: Full-Height Severe Spall with exposed steel extending between manhole refuge niches, North Bench Wall near Line 2 Station 82+14. No steel plates were installed to cover missing concrete along top of bench. Photo Ref. GK12-042, looking End, North.

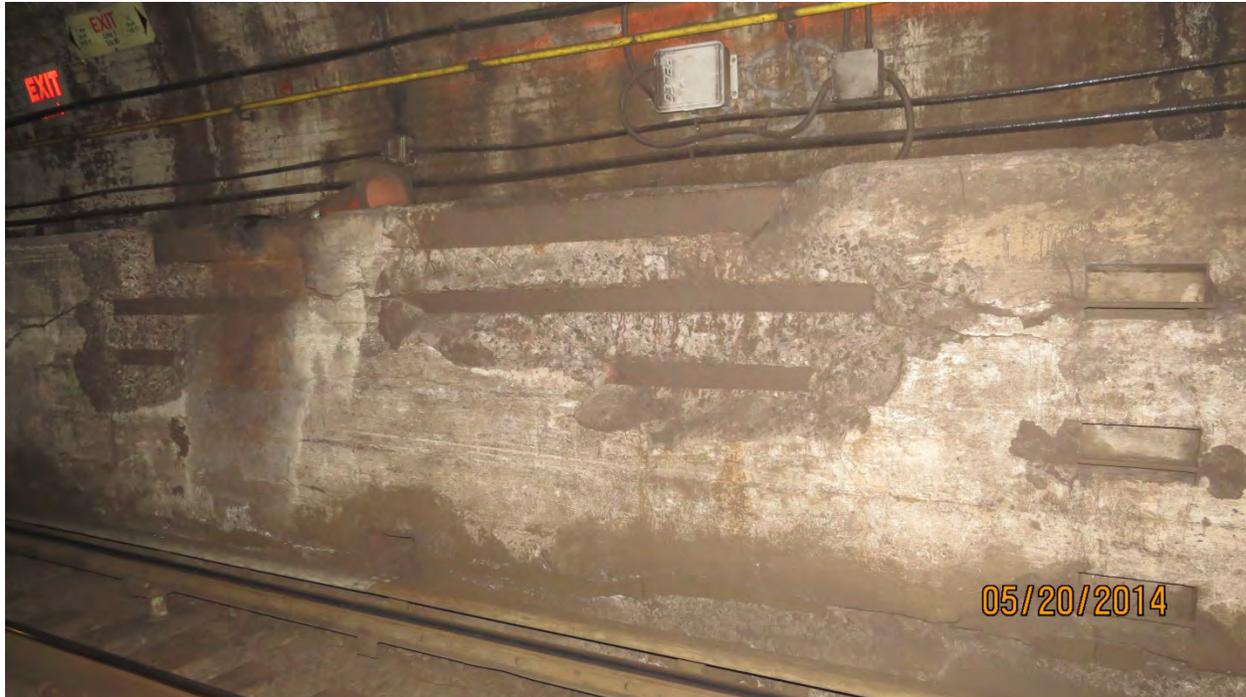
Photo E14: Severe Spall with exposed steel at Splicing Vault, North Bench Wall near Line 1 Station 79+87. Photo Ref. GK11-023, looking End, North.

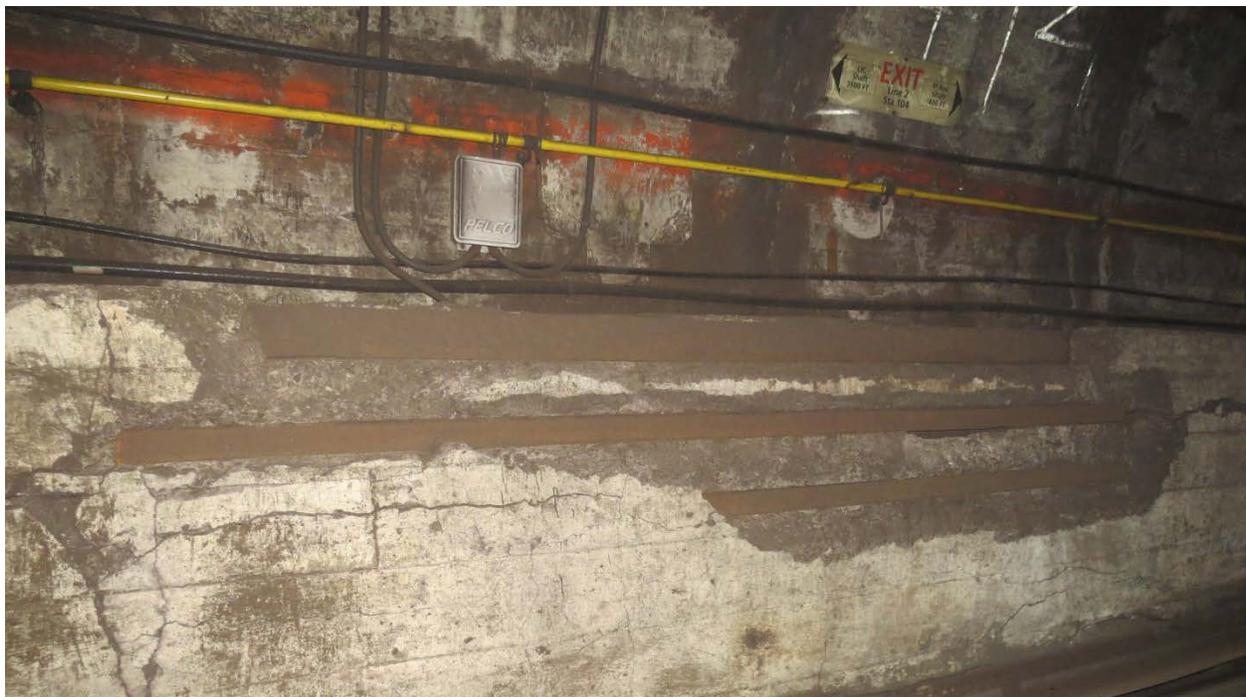
Photo E15: Severe Spall with exposed steel at Splicing Vault, South Bench Wall near Line 2 Station 103+99. Photo Ref. BBS1 IMG_0028, looking End, South.

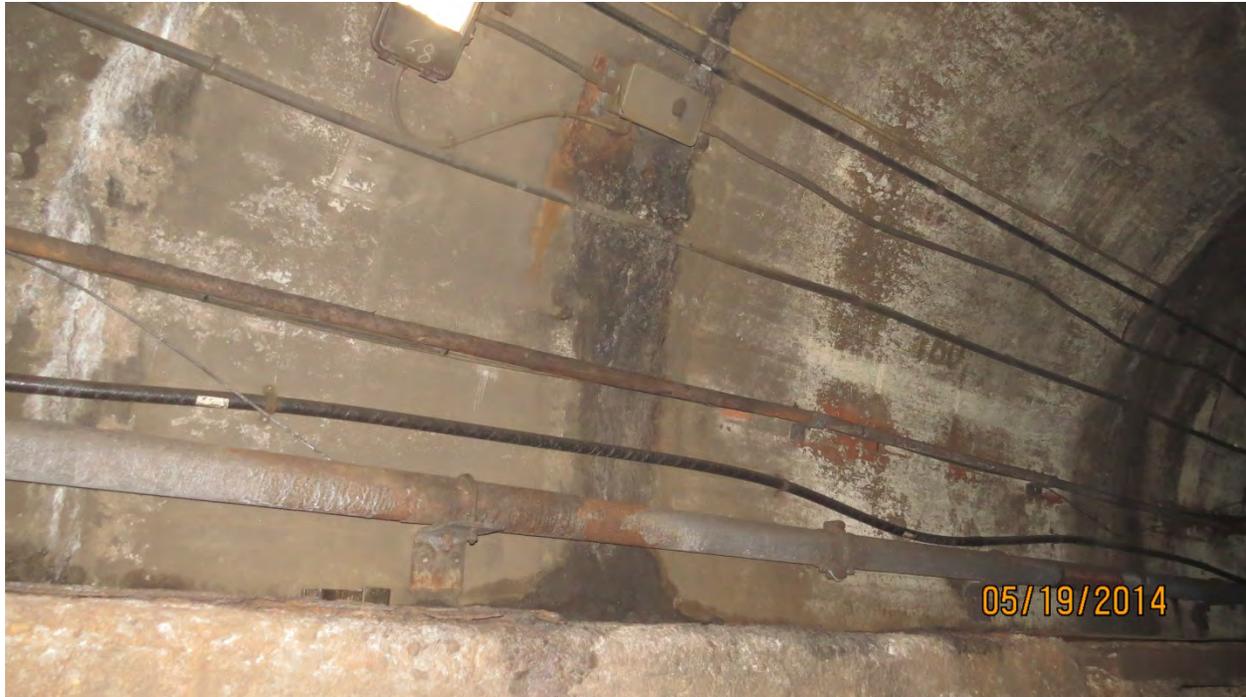
Photo E16: Efflorescence, Damp Incrustation, and Active Moisture along transverse joint, North Wall, Line 2 Station 91+50. Moderate buildup of incrustation on wall and top of bench. Photo Ref. GK10-079, looking North.

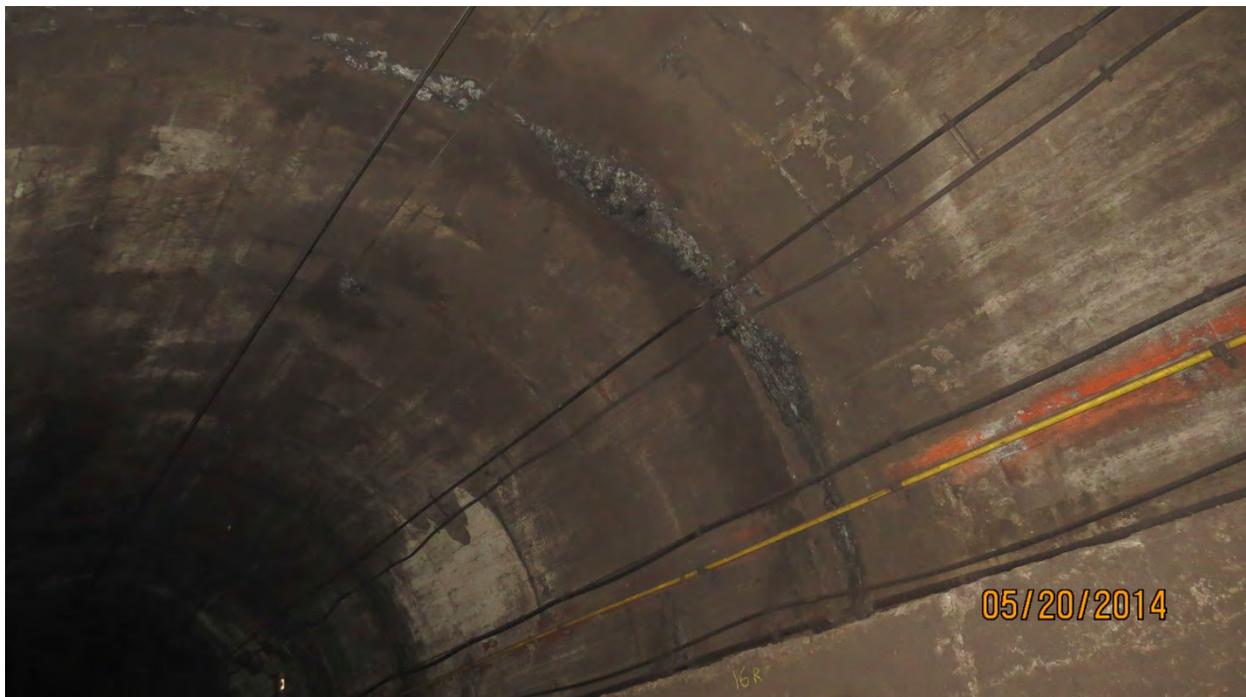
Photo E17: Efflorescence, Damp Incrustation, and Active Moisture along transverse joint, North Wall, Line 1 Station 95+29. Photo Ref. GK11-071, looking End, North.

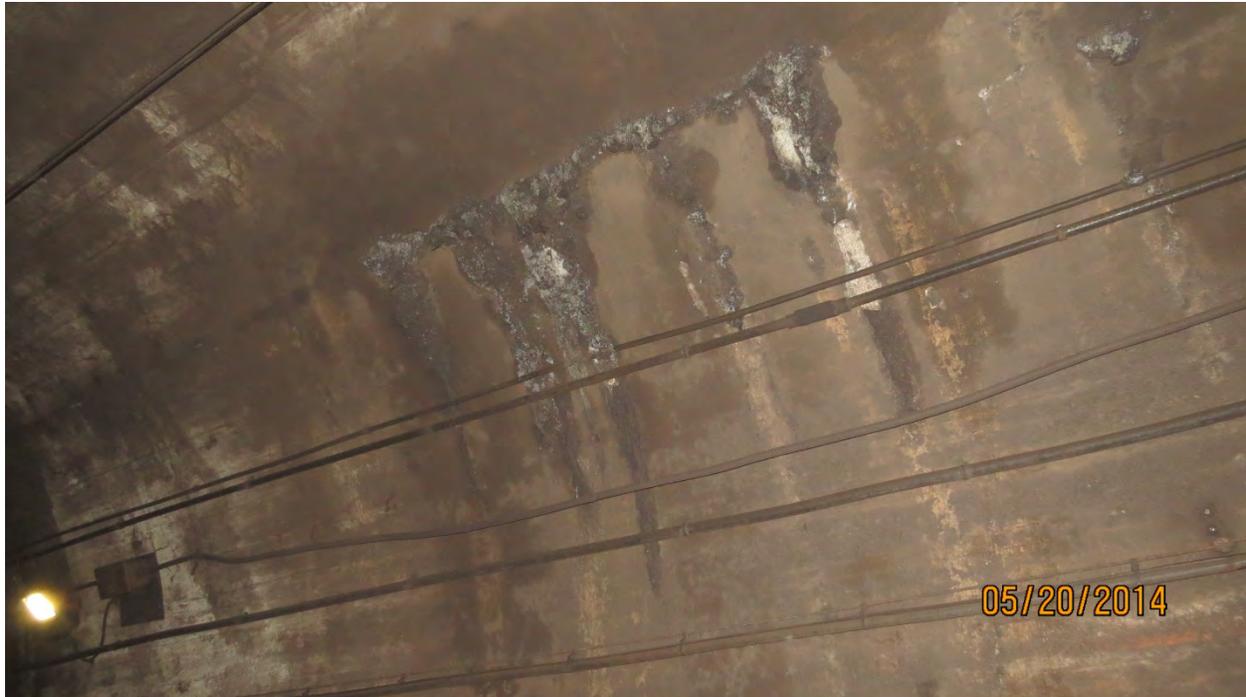
Photo E18: Efflorescence, Damp Incrustation, and Active Moisture along longitudinal joint, South Wall, Line 1 Station 95+45. Photo Ref. GK11-078, looking Begin, South.

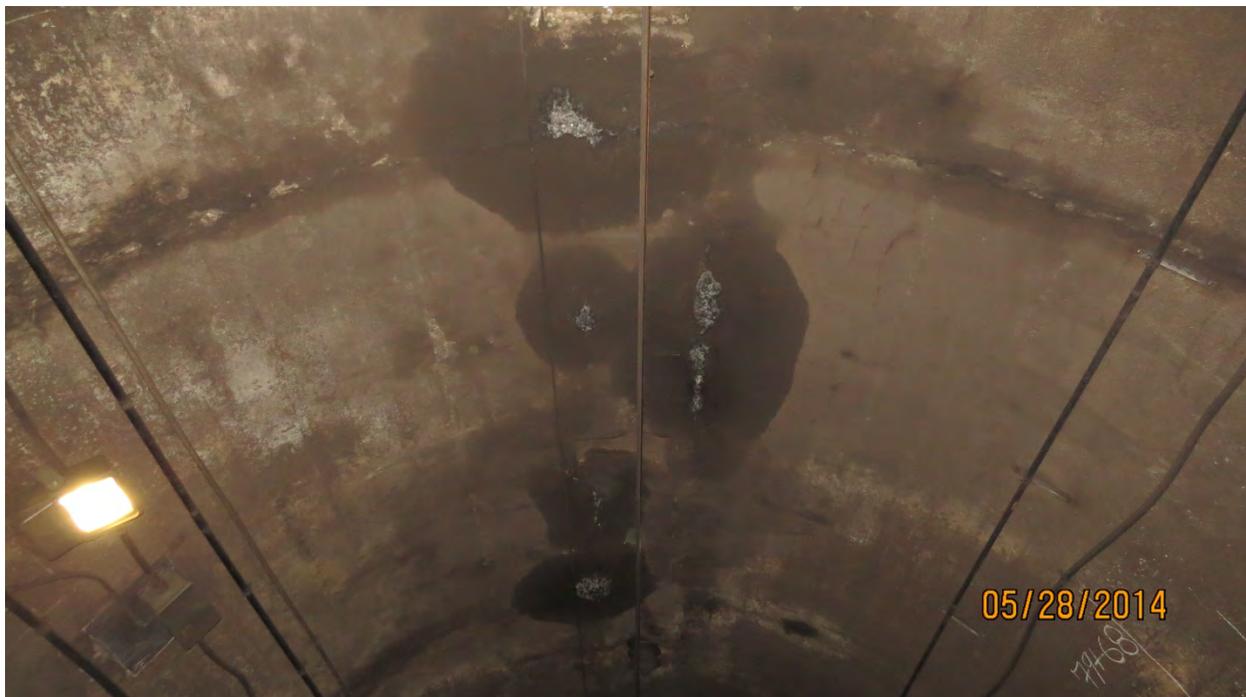
Photo E19: Efflorescence, Damp Incrustation, and Active Moisture along longitudinal joints near Crown, South and North Walls, Line 2 Station 79+68. Photo Ref. GK12-049, looking End, Up.

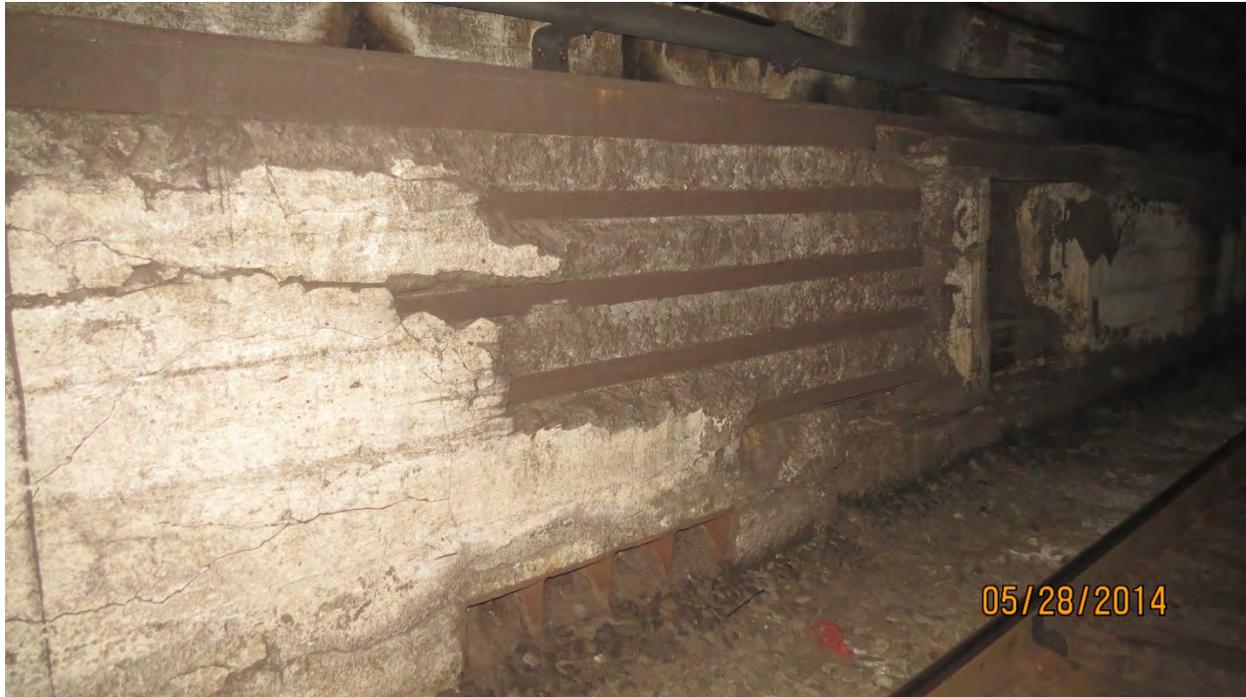
Photo E20: Cracked, Delaminated Concrete adjacent to Severe Spall with exposed steel on North Bench Wall, Line 2 Station 90+38. Total deficient area was 18' long x full height x up to 16" deep locally, near manhole niche. Photo Ref. GK12-029, looking Begin, North.

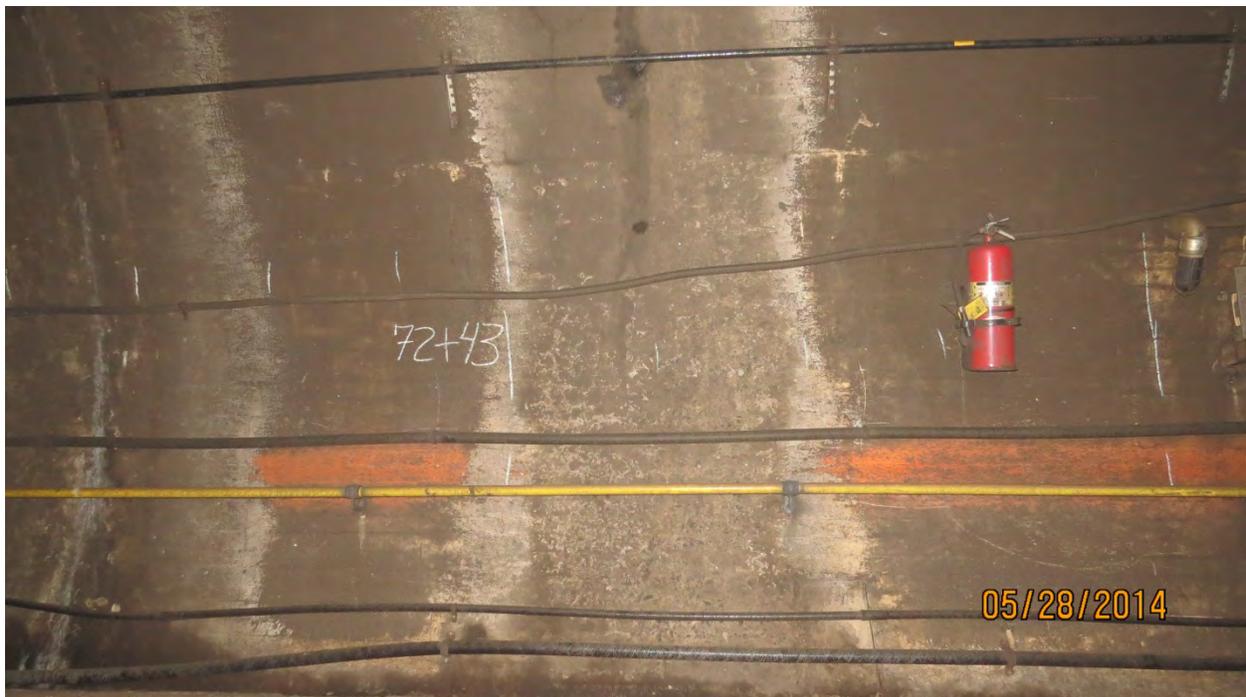
Photo E21: Honeycombing over an area 4' long x 5' wide adjacent to top of bench, South Wall, Line 2 Station 72+43. Photo Ref. GK12-072, looking South.

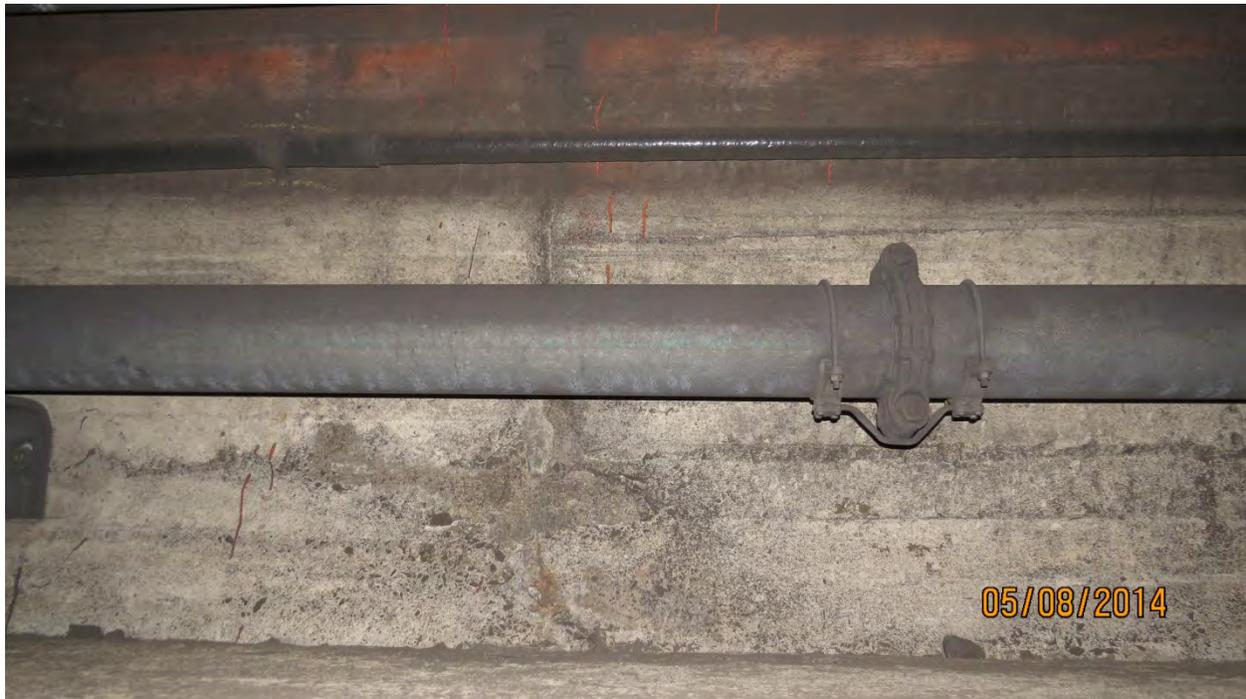
Photo N1: General View of Transverse Moderate Crack up to 1/16" wide on North Wall, North Tube Station 232+51. Photo Ref. GK03-036, looking North.

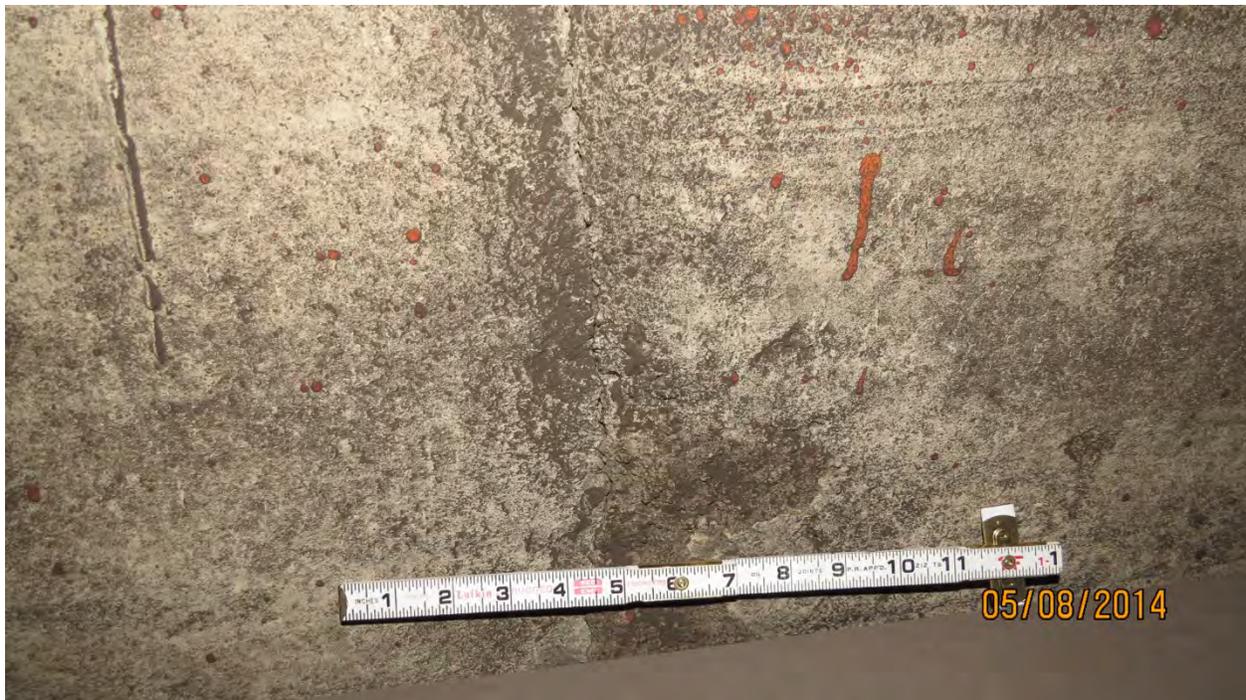
Photo N2: Close-Up of Transverse Moderate Crack up to 1/16" wide on North Wall, North Tube Station 232+51. Photo Ref. GK03-039, looking North.

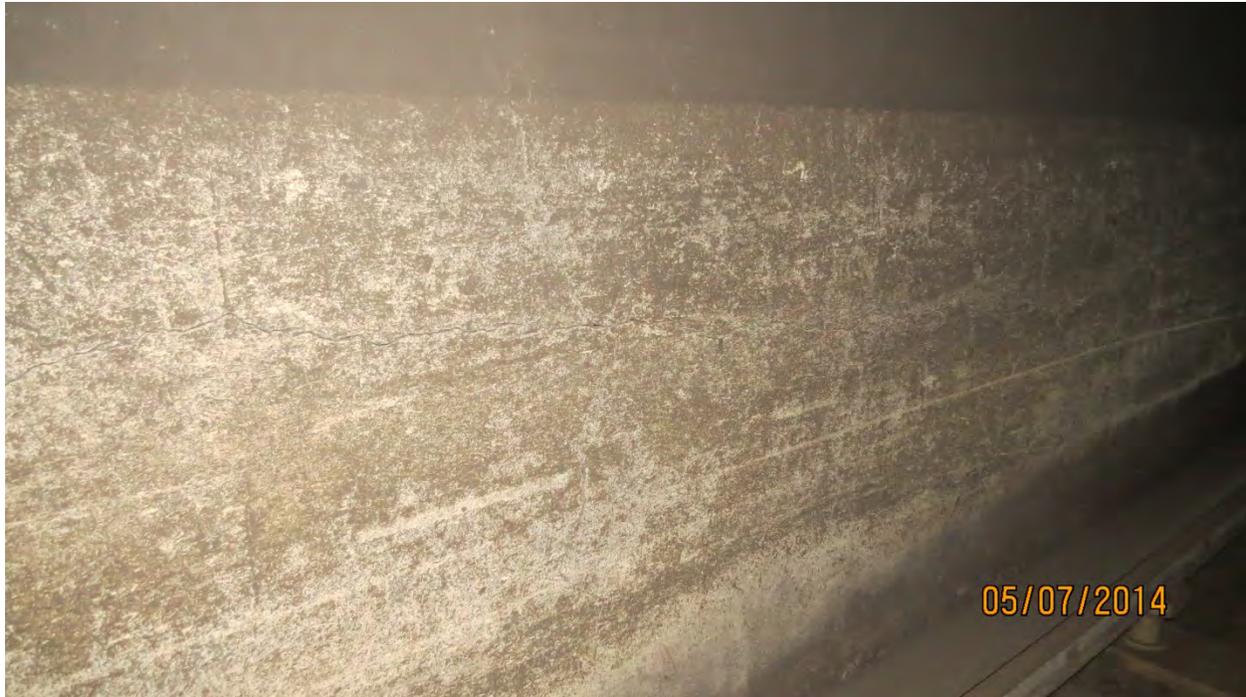
Photo N3: Longitudinal Moderate Crack up to 1/8" wide and Transverse Moderate Crack up to 1/16" wide, South Bench Wall, North Tube Station 225+42. Note the high water line from the inundation near top of image. Photo Ref. GK02-031, looking End, South.

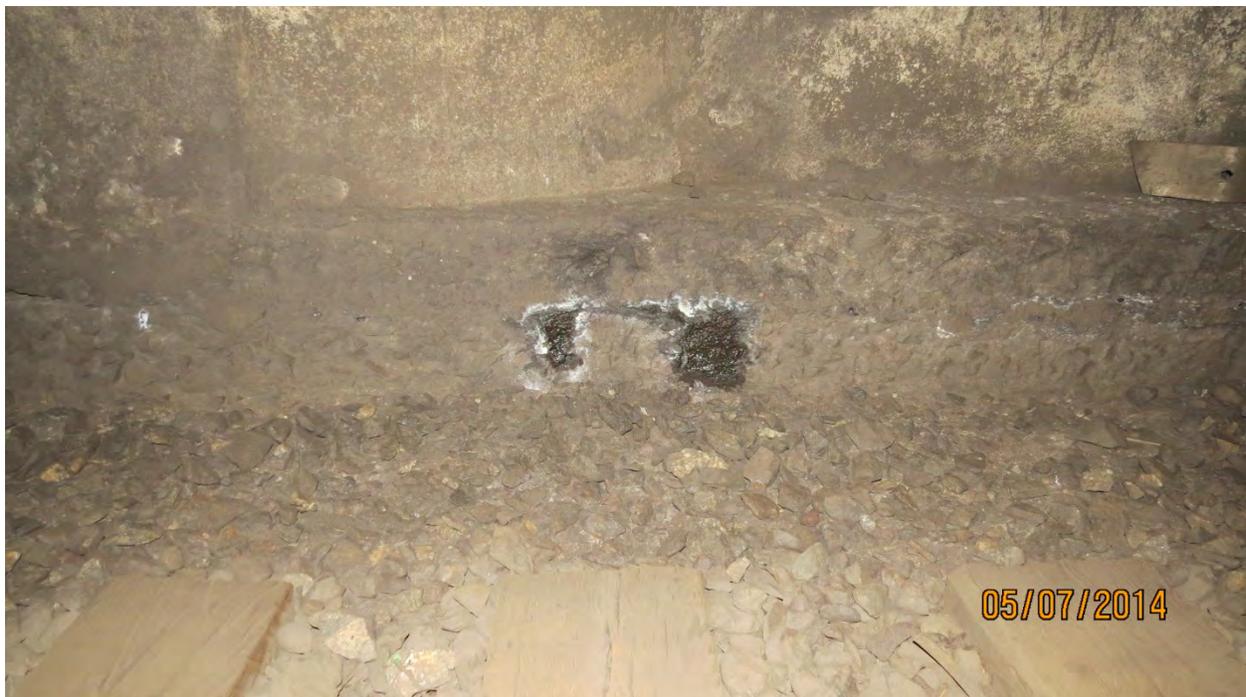
Photo N4: Short longitudinal Moderate Crack with efflorescence and Active Moisture with inflow of a few drops per minute. Crack is located near bottom of North Bench Wall, North Tube Station 224+66. Photo Ref. GK02-027, looking North.
