Structural Assessment of the Amtrak Under River Tunnels in NYC Inundated by Super Storm Sandy

Executive Summary

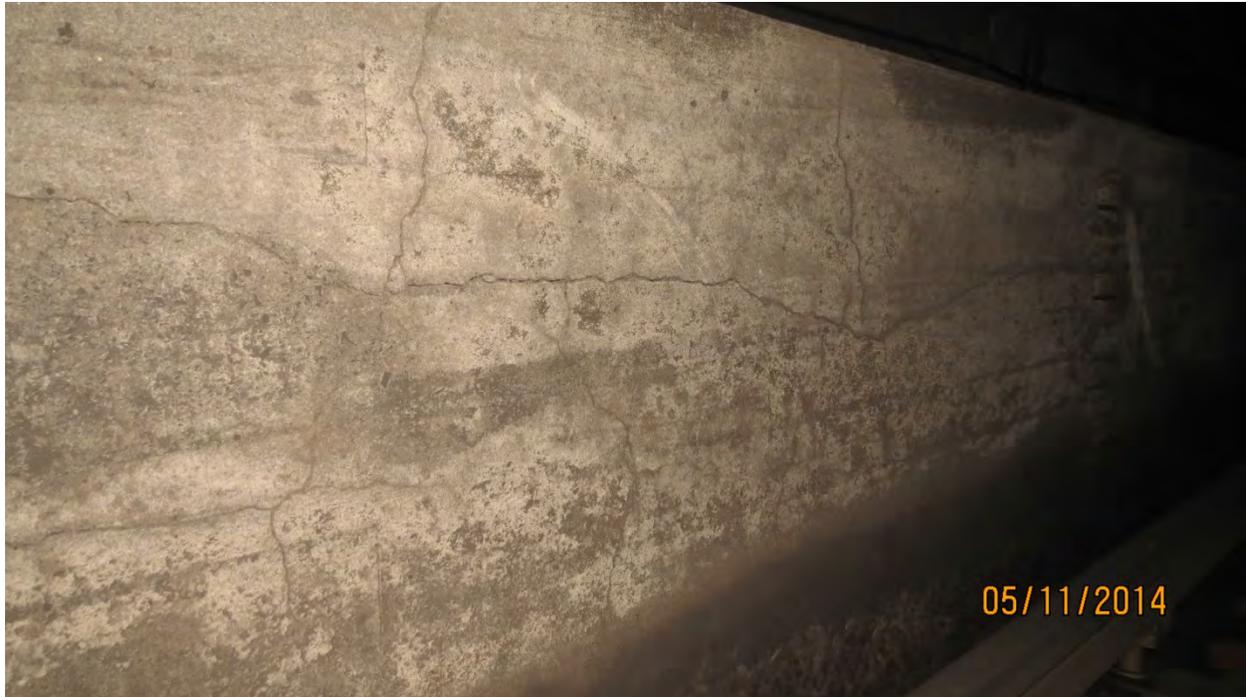
Photo N5: Longitudinal crack up to 3/16" wide and scattered transverse cracks up to 1/16" wide, South Bench Wall, North Tube Station 246+81. Damp concrete on lower 2' to 3' of wall and honeycombing on lower 1' to 2' of wall. Photo Ref. GK06-034, looking End, South.

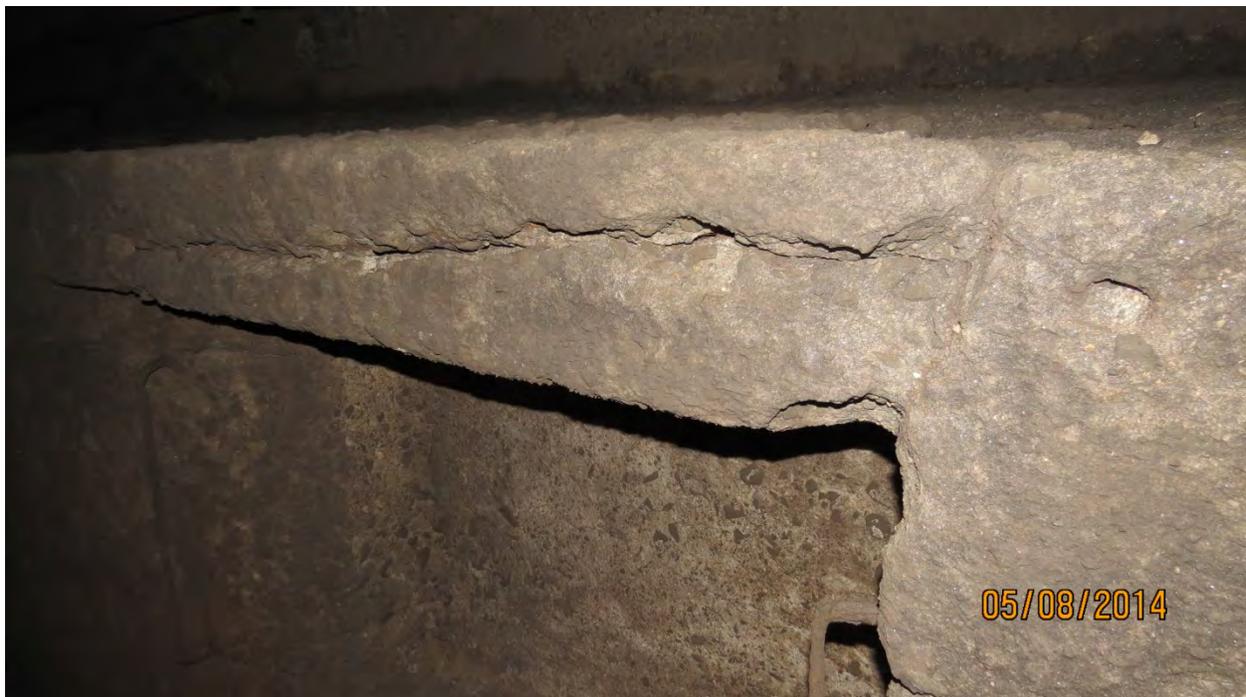
Photo N6: Longitudinal Severe Crack 5' long x up to 5/16" wide between manhole refuge niche and Top of Bench, North Bench Wall, North Tube Station 233+36. Photo Ref. GK03-047, looking End, North.

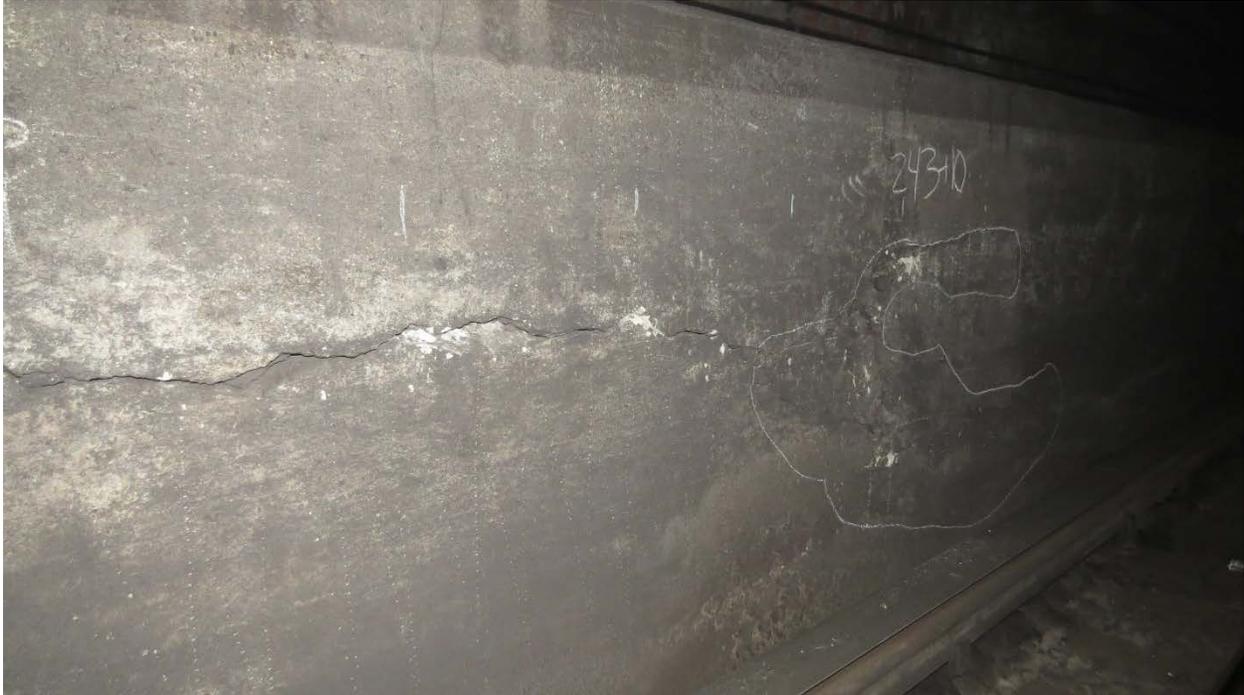
Photo N7: Longitudinal Severe Crack 110' long x up to 1/4" wide with scattered Moderate Spalls along crack and Concrete Delamination 8' long x 4' high near Station 243+10. North Bench Wall, South Tube Station 243+20. Photo Ref. GK05-035, looking Begin, North.

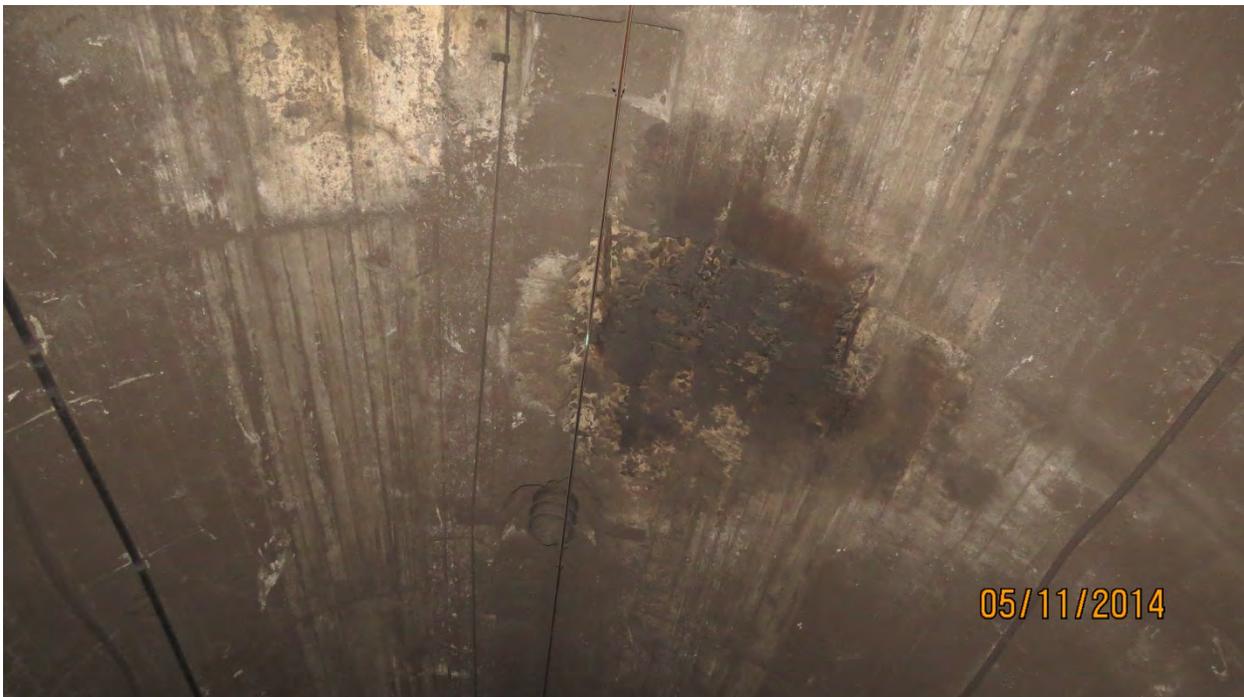
Photo N8: Two Severe Spalls with exposed rebar, 7' long x 1' wide x 4" to 5" deep and 2' long x 1' wide x 4" deep, near Crown, with adjacent Honeycombing and Active Moisture. South Wall, North Tube Station 251+75. Photo Ref. GK06-042, looking Begin, Up.

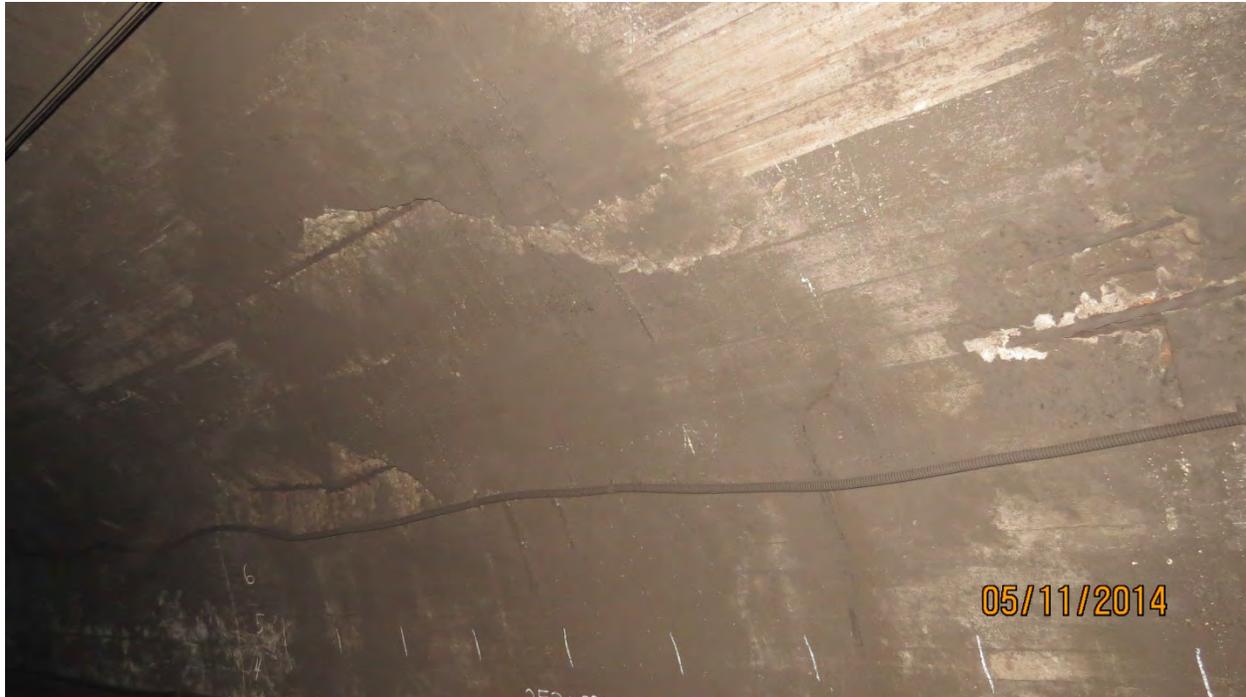
Photo N9: Three 4" deep Severe Spalls with exposed rebar, 6' long x 2' wide, 4-1/2' long x 1' wide and 3' long x 2' wide, on South Wall near North Tube Station 252+82. Delaminated Concrete 18' long x 5' wide between spalls. Photo Ref. GK06-047, looking Begin, South.

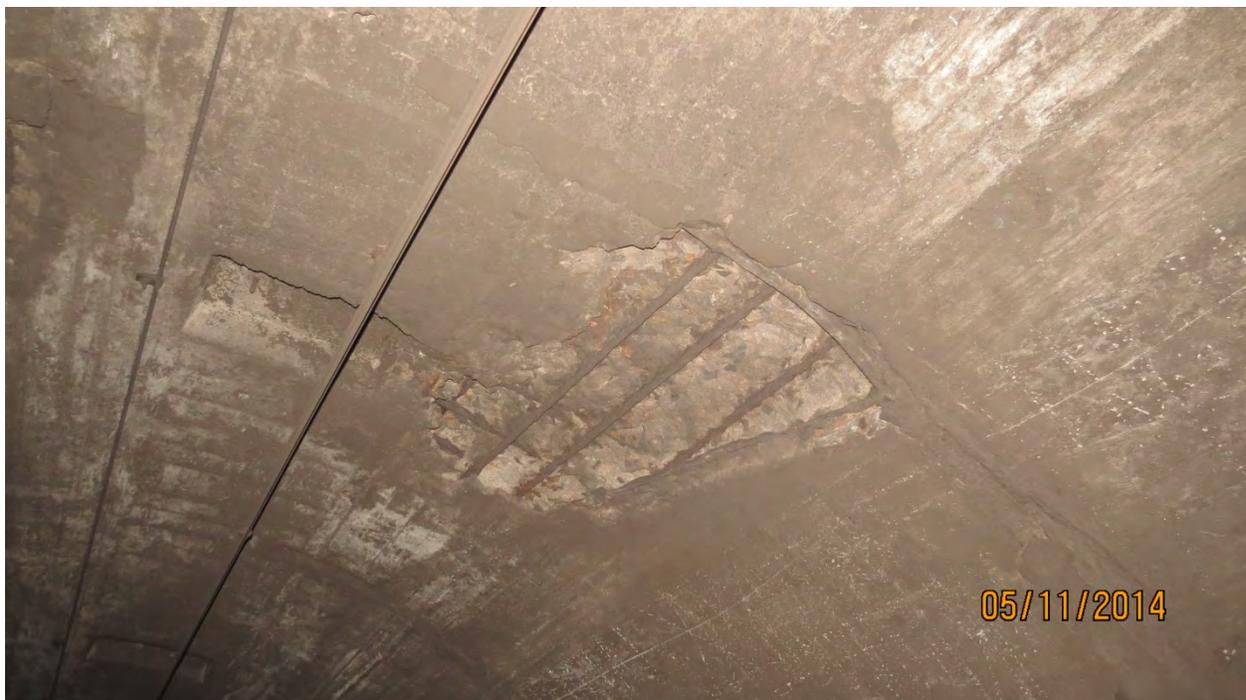
Photo N10: Severe Spall 6' long x 4' wide x 5" deep with exposed rebars on South Wall near North Tube Station 259+00. Areas of Concrete Delamination 6' long x 4' wide and 4' long x 3' wide adjacent to spall. Photo Ref. GK06-056, looking Begin, Up.

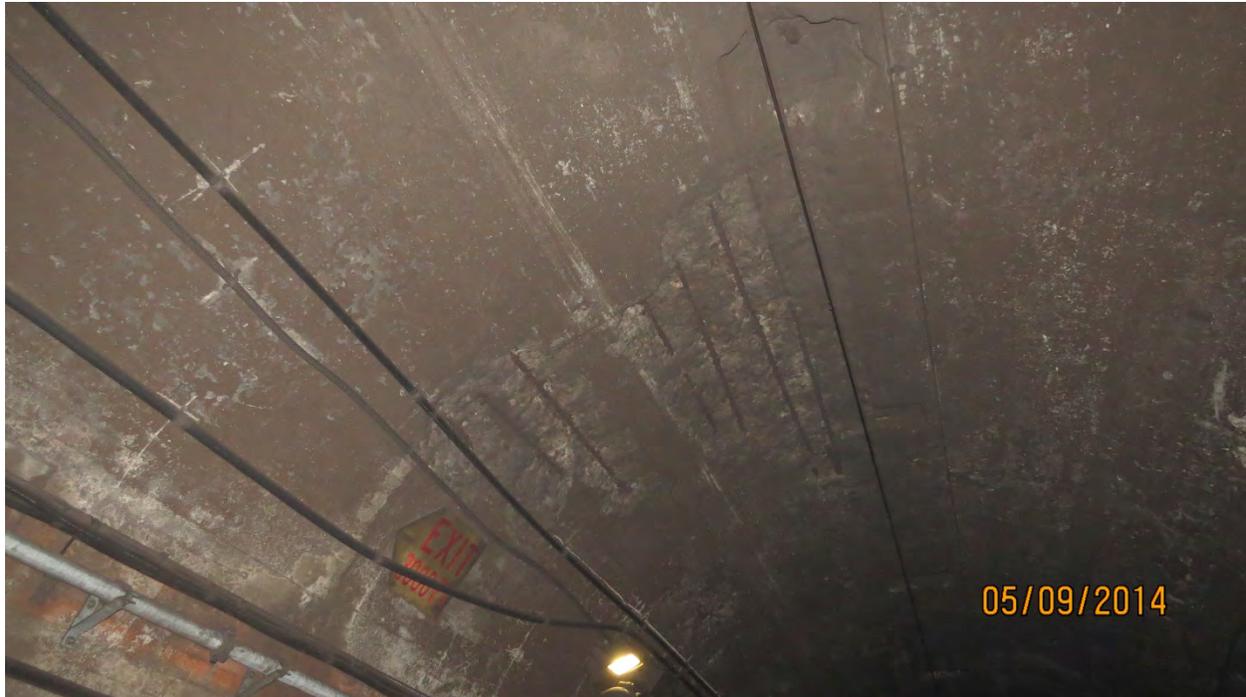
Photo N11: Two Severe Spalls with exposed rebar, 10' long x 4-1/2' wide x 4" to 5" deep and 6-1/2' long x 3' wide x 3" to 4" deep, on South Wall near South Tube Station 227+78. Photo Ref. GK04-020, looking End, Up.

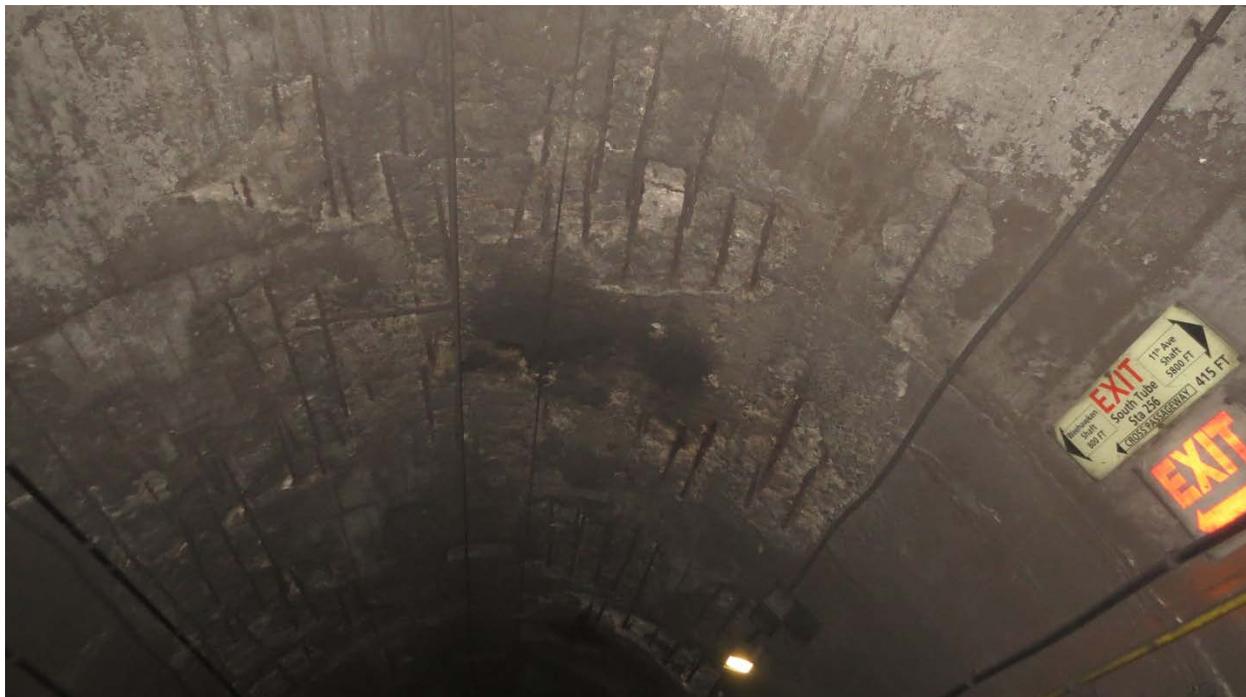
Photo N12: Several Severe Spalls up to 4" deep with exposed rebar over a 37' length of the South Tube. Spalls occur between the 10:00 and 2:00 positions on the South and North Walls, beginning near South Tube Station 256+00. Photo Ref. GK05-060, looking End, Up.

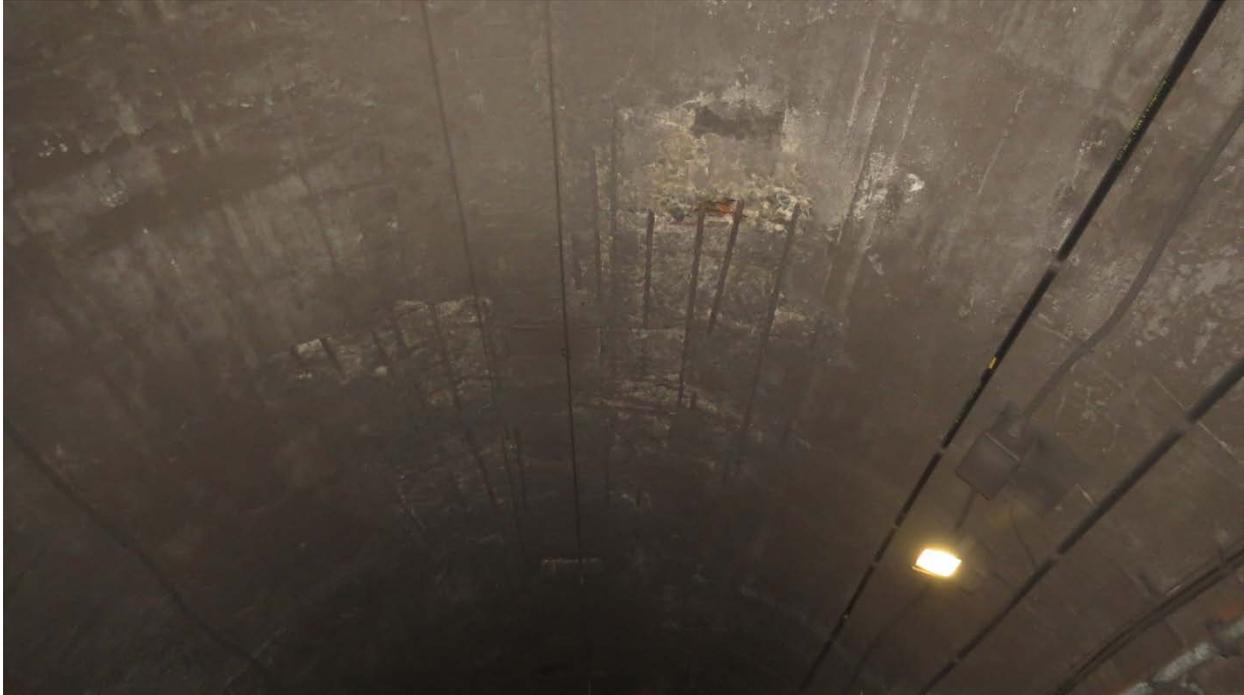
Photo N13: Severe Spalls up to 4" deep with exposed rebar between 10:00 and 2:00 positions on South and North Walls over a 50' length of South Tube. A 1' x 1' area near South Tube Station 256+80 was a locally deep Void/Hole. Photo Ref. GK05-067, looking Begin, Up.

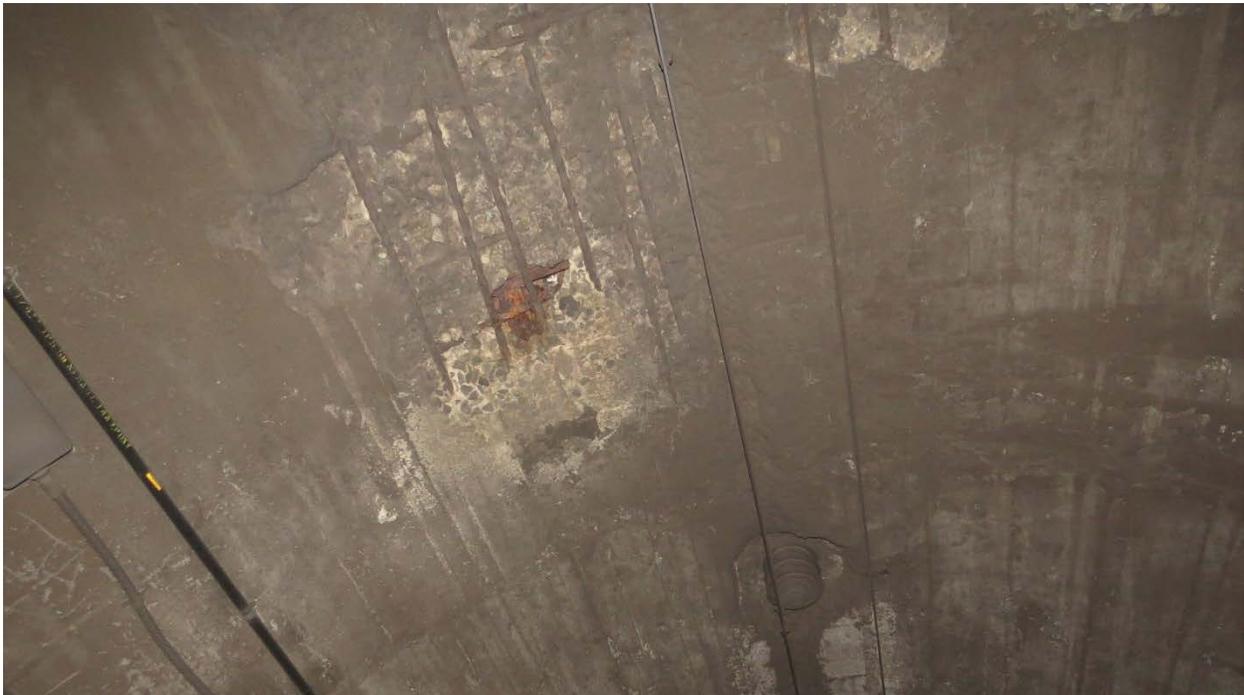
Photo N14: Close-Up of 4" deep Severe Spall with exposed rebar and 1' long x 1' wide locally deep Void/Hole in concrete lining, South Wall, near South Tube Station 256+80. Photo Ref. GK05-065, looking End, South, Up.

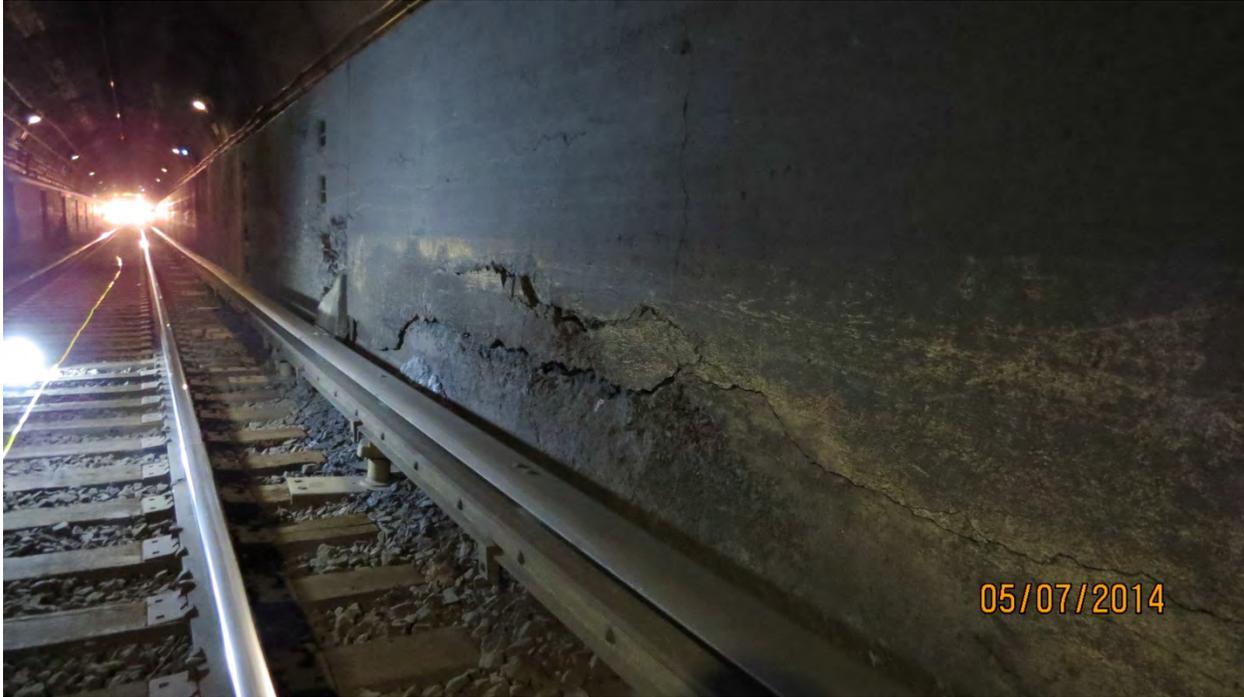
Photo N15: Longitudinal Severe Cracks, Delaminated Concrete 12' long x 3' high and localized Severe Spalls up to 4" deep in South Bench Wall near North Tube Station 222+64. Photo Ref. GK02-023, looking Begin, South.

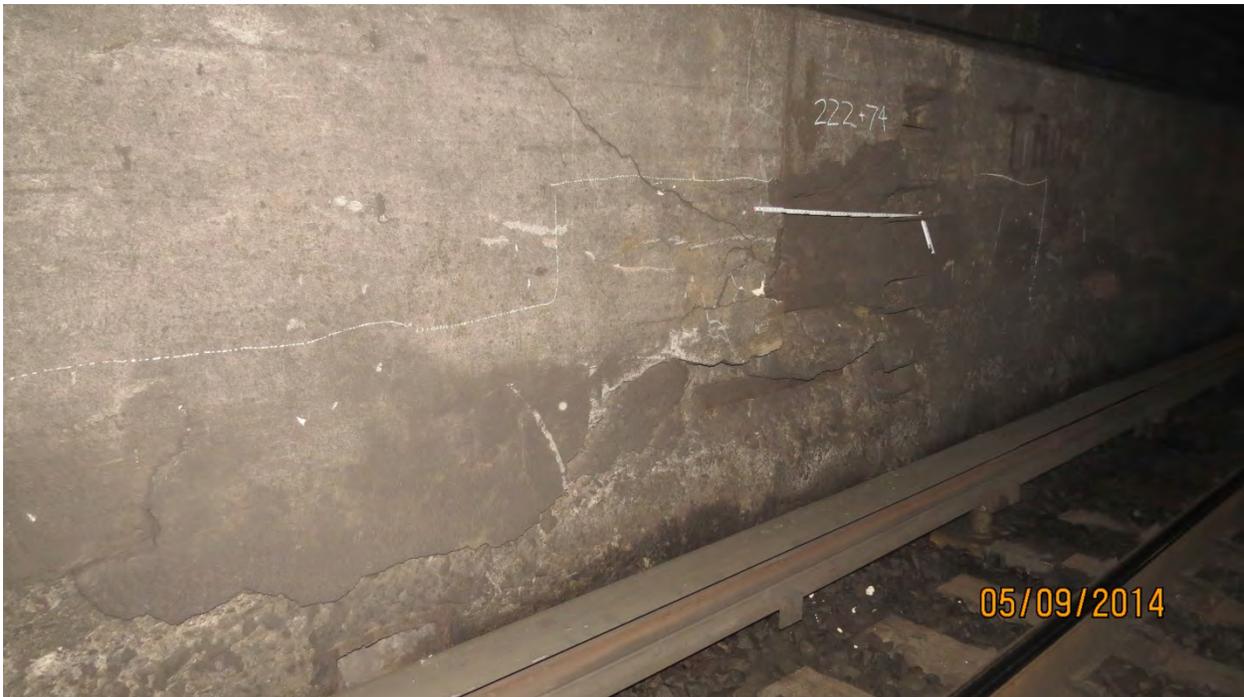
Photo N16: Delaminated Concrete 21' long x 3' to 4-1/2' high and a Severe Spall 5' long x 3' high x up to 4-1/2" deep on North Bench Wall near South Tube Station 222+54. Photo Ref. GK04-006, looking North.

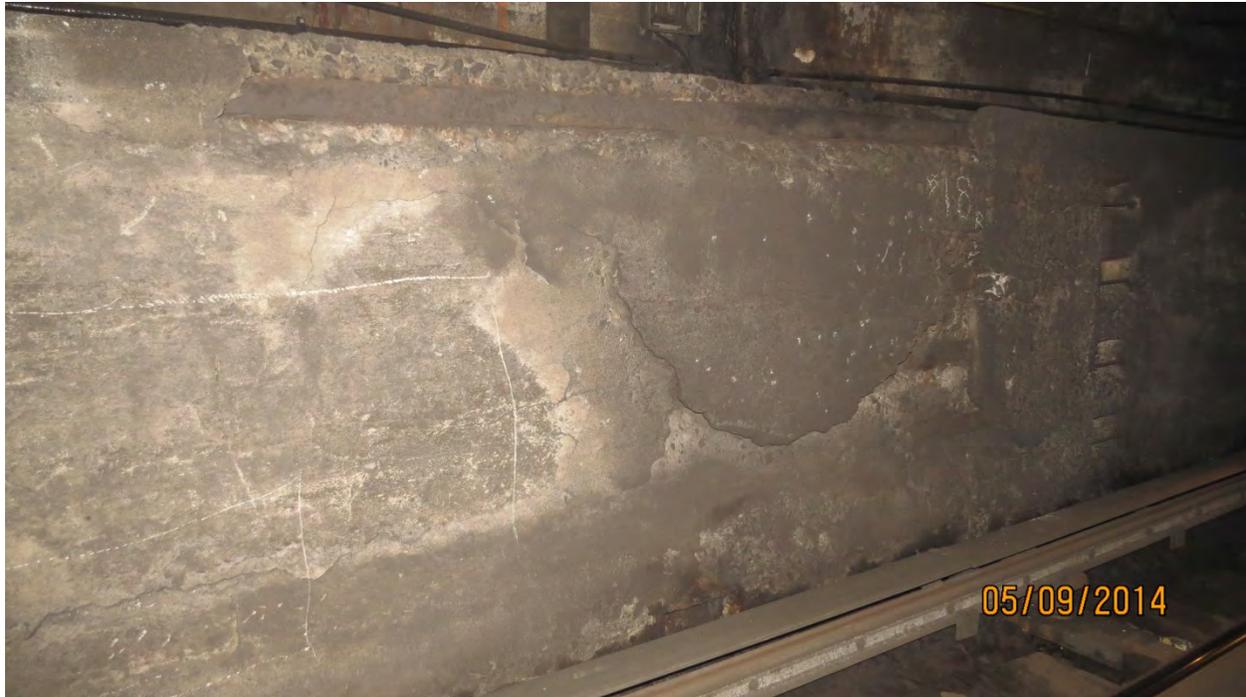
Photo N17: Delaminated Concrete area, 20 square feet, and Severe Spalls with exposed steel, 10' long x 1' high x up to 5-1/2' deep and 6' long x 3' high x 4" deep on North Bench Wall near South Tube Station 238+50. Photo Ref. GK04-077, looking Begin, North.

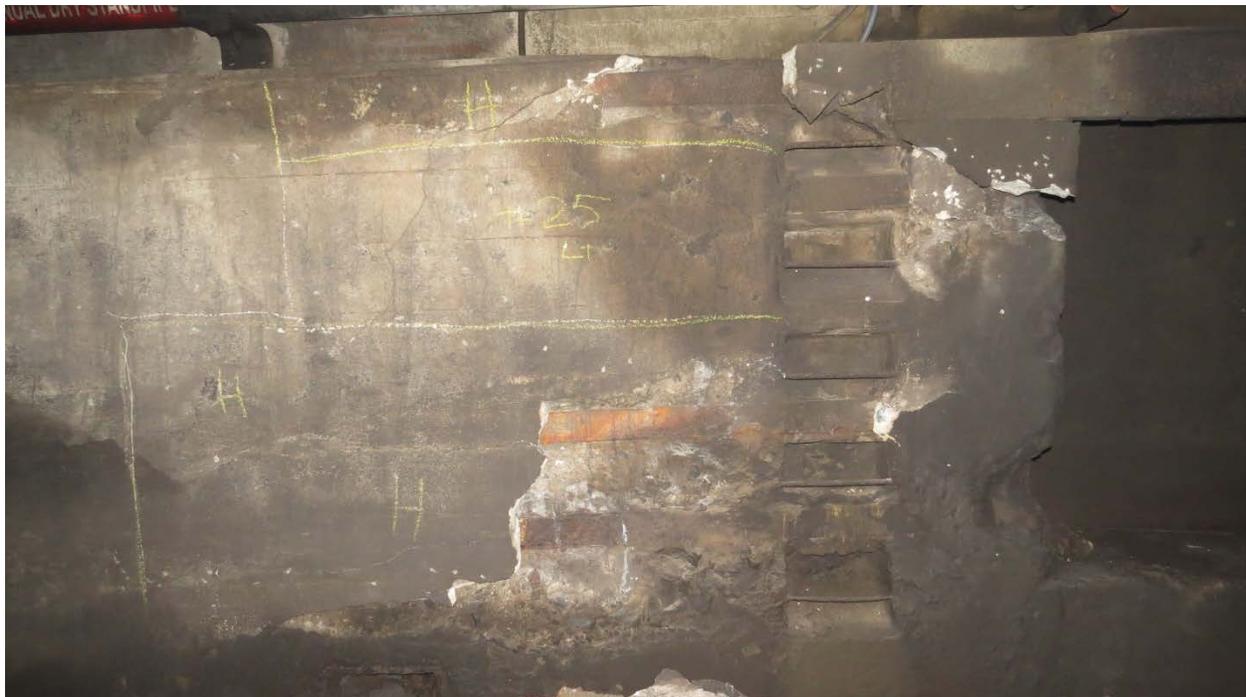
Photo N18: Delaminated Concrete area, 40 square feet, and Severe Spalls with exposed steel on South Bench Wall, 4' long x 3' high x 3-1/2" deep and 2-1/2' L x 1' high x up to 6" deep, at South Tube Station 241+03. Photo Ref. GK05-020, looking South.

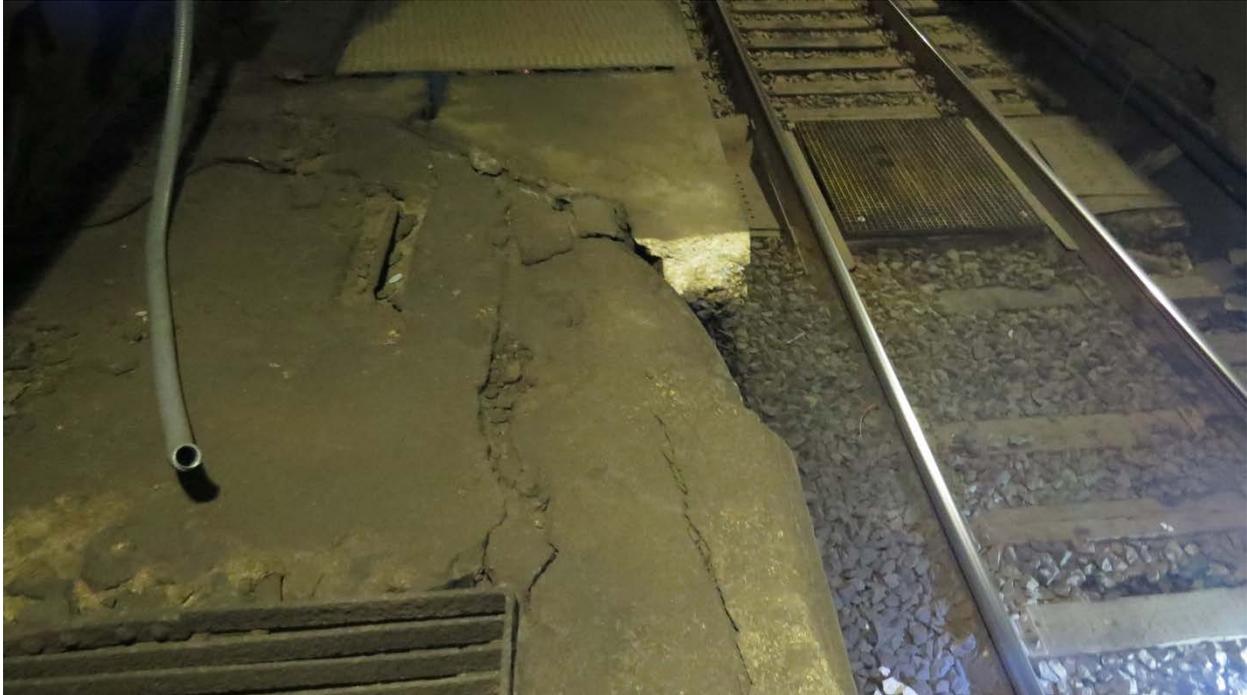
Photo N19: Cracked, Spalled Concrete on Top of Bench above location with Severe Spalls, South Bench Wall near South Tube Station 241+03. Up to 6" of concrete is missing, and top surface is severely cracked. Photo Ref. GK05-023, looking End, Down.

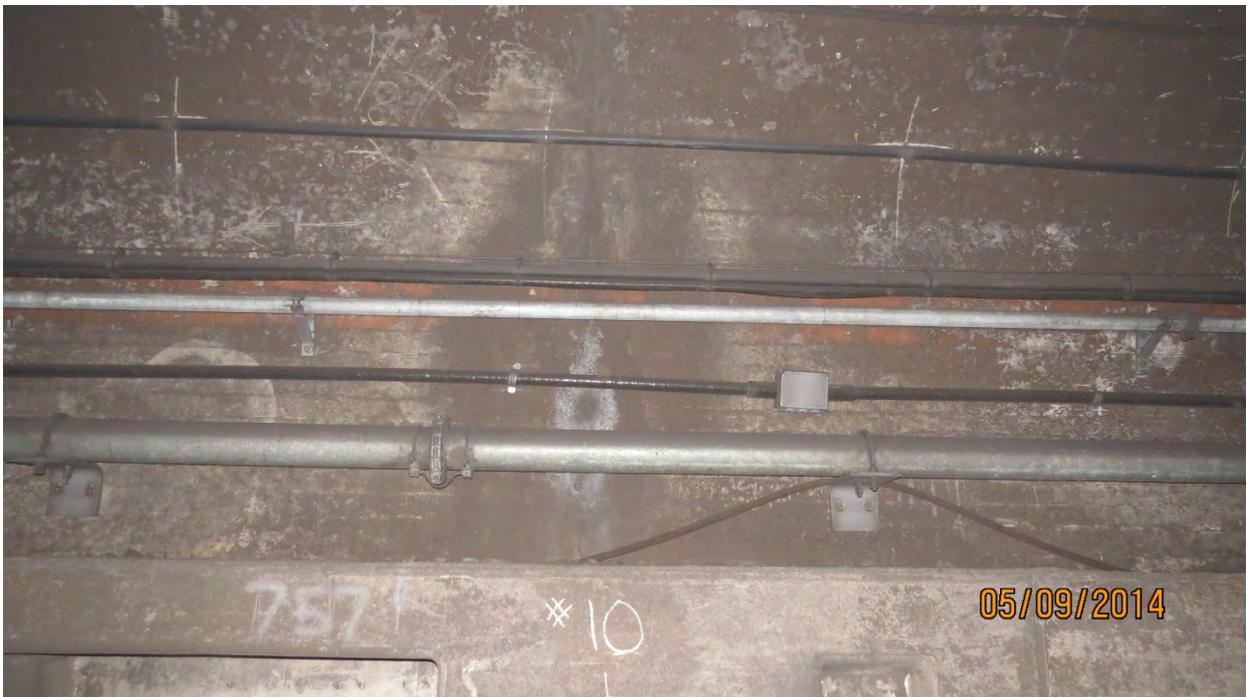
Photo N20: Light Efflorescence along transverse joint, on South Wall at South Tube Station 233+13. Photo Ref. GK04-046, looking South.

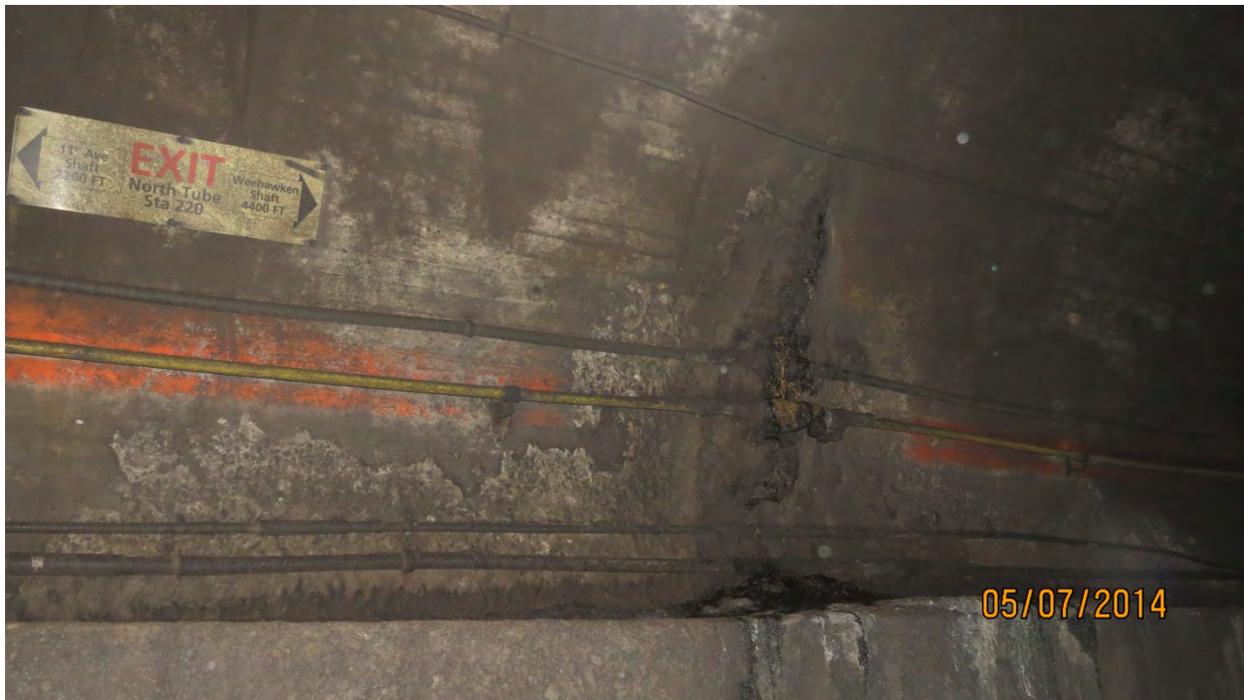
Photo N21: Incrustation and Active Moisture between 9:00 and 10:00 positions, South Wall at North Tube Station 220+09. Incrustation up to 7" deep on wall, top of bench with moderate leakage of several drops per minute. Photo Ref. GK02-006, looking End, South.

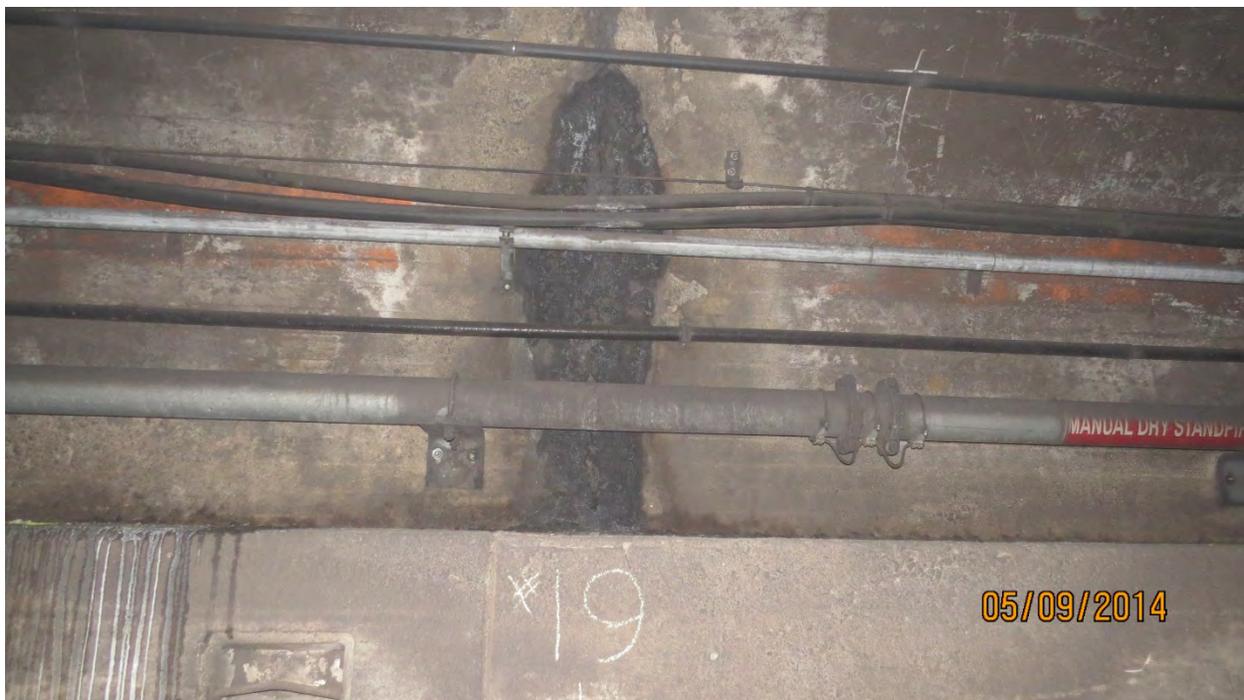
Photo N22: Damp incrustation up to 2" thick and minor Active Moisture along transverse joint below the 9:30 position on South Wall at South Tube Station 238+50. Photo Ref. GK04-080, looking South.

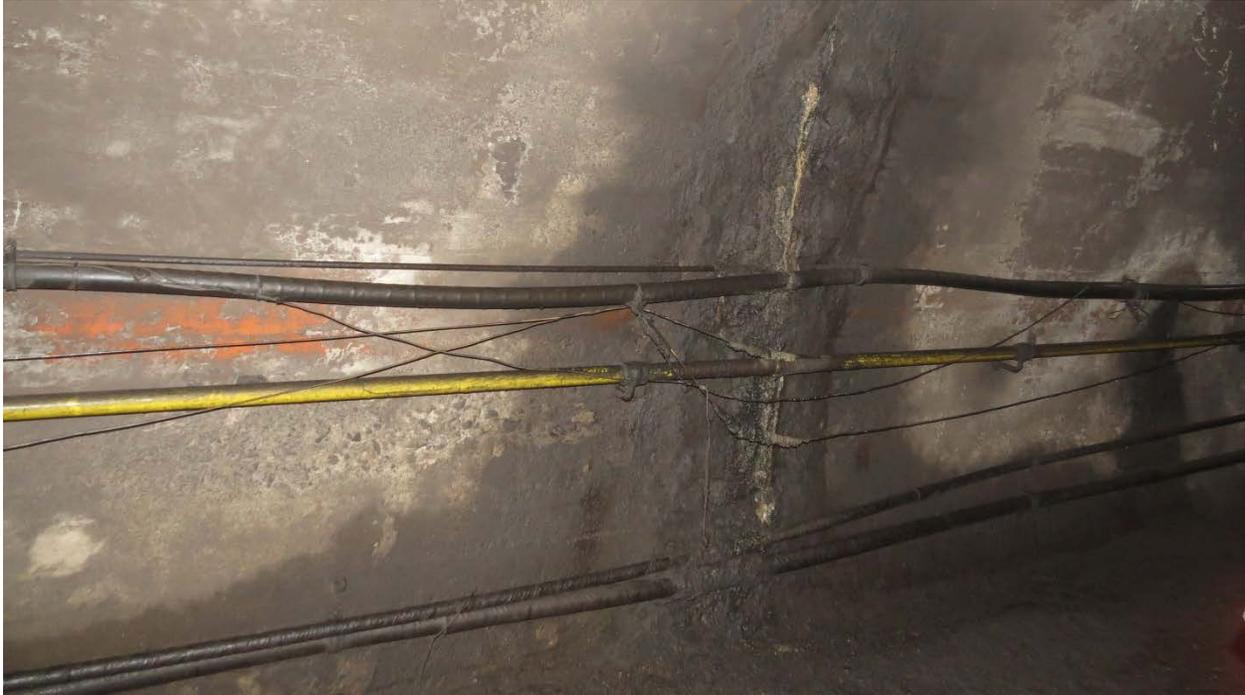
Photo N23: Wet Incrustation and Active Moisture below 2:00 position, with leakage of several drops per minute. Incrustation 3'' to 4'' thick was observed on wall and top of bench. North Wall, South Tube Station 238+67. Photo Ref. GK05-009, looking Begin, North.

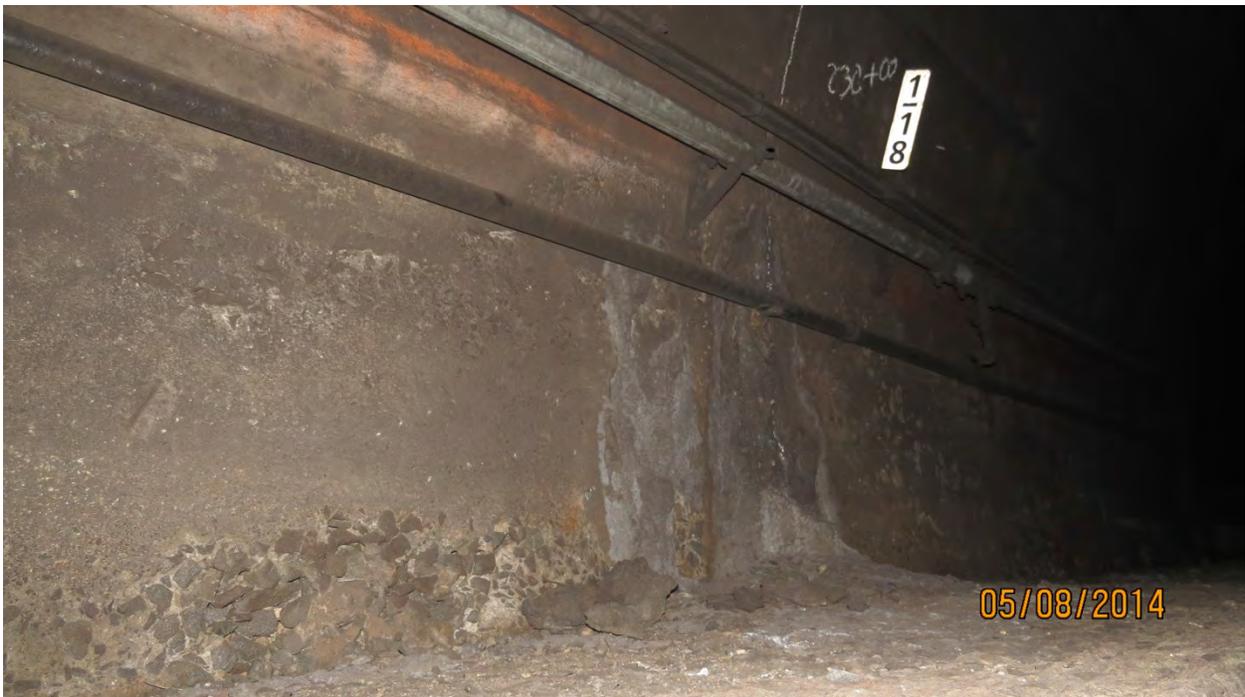
Photo N24: Honeycombing 3' long x 1' wide on wall along top of bench, North Wall, near North Tube Station 230+24. Photo Ref. GK03-028, looking Begin, North.

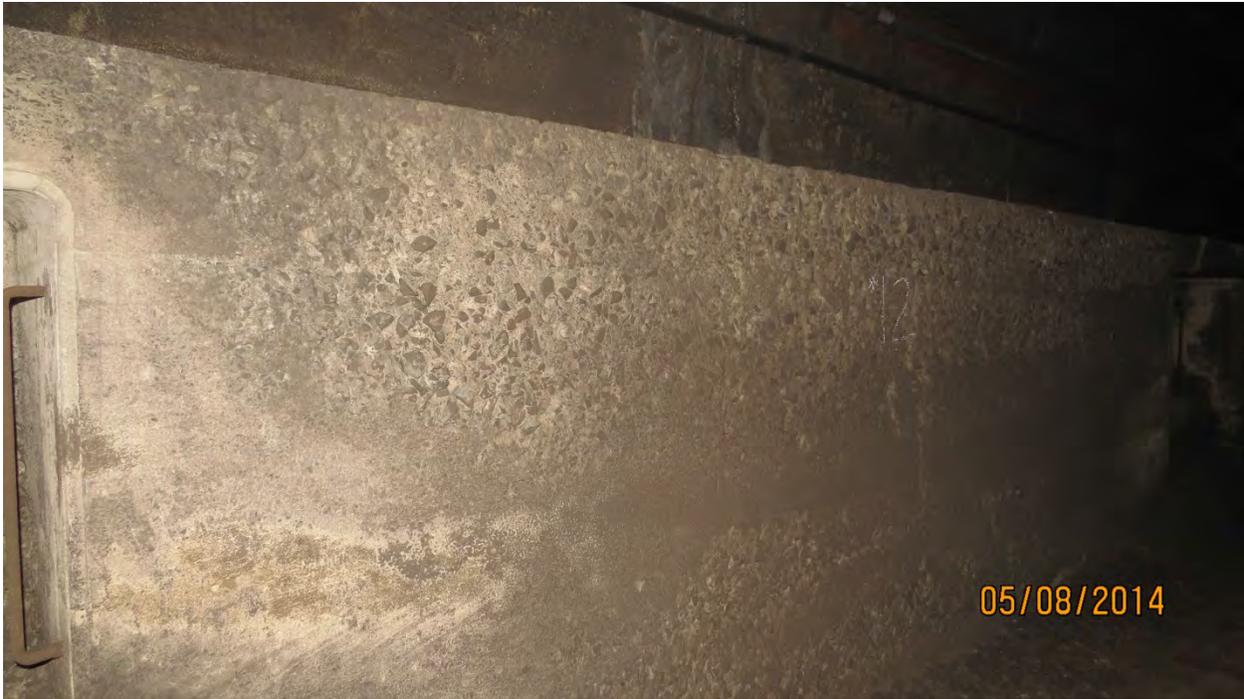
Photo N25: Honeycombing over approximately 60% of surface area of bench wall between adjacent manhole refuge niches. North Bench Wall, near North Tube Station 230+24. Photo Ref. GK03-029, looking Begin, North.
