Structural Assessment of the Amtrak Under River Tunnels in NYC Inundated by Super Storm Sandy

Executive Summary

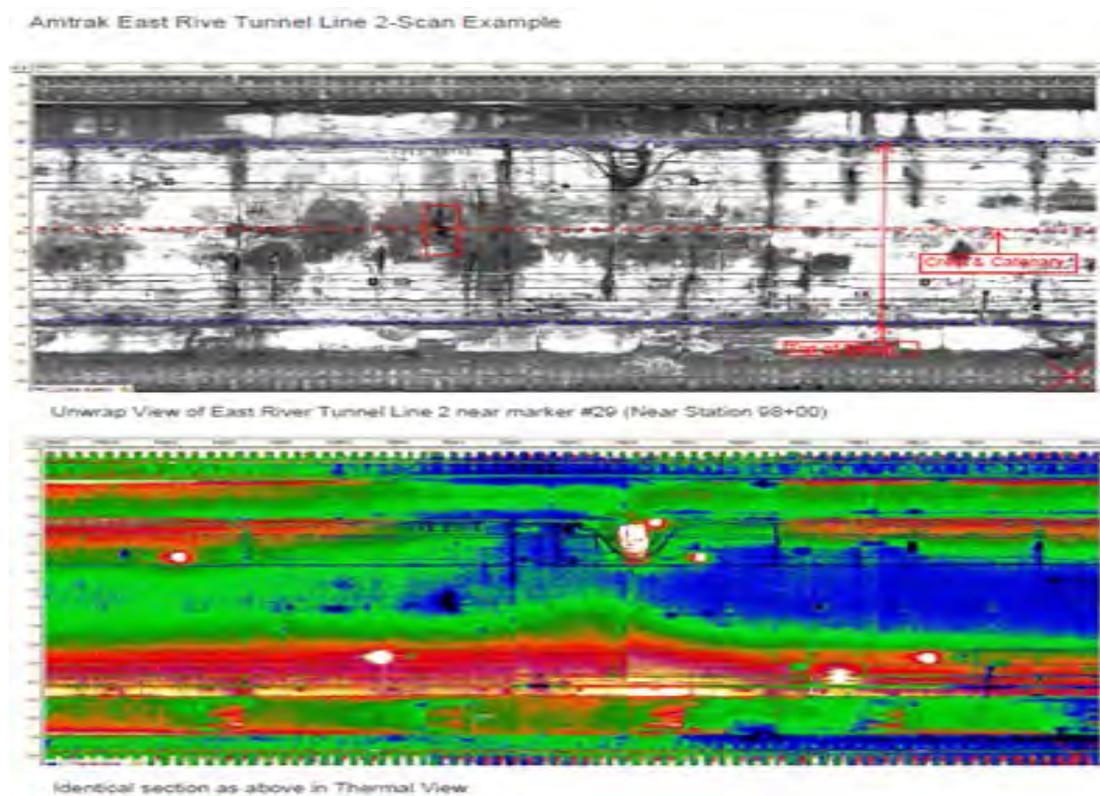
Figure 11 – Example of Scan Results

The thermal recordings give an indication of defects in the tunnel structures that are not readily apparent to the naked eye. Warm areas typically indicate potential voids, while cool areas typically indicate areas of possible concrete delamination or water infiltration. Normal conditions are signified by colors ranging from green to orange. All three data recordings: thermal, photography, and 3-D are made at the same time and coincide with each other. These images allow for an objective assessment of potential structural integrity issues and water infiltration locations. Figure 11 presents an example of a typical scan output, the upper image shows the laser results and the lower image shows the thermal results. The scan results are presented in Appendix A.

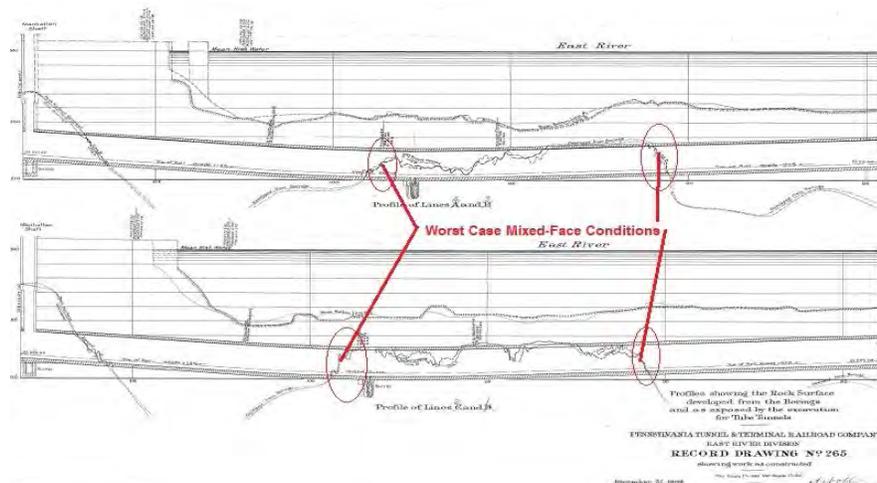
Figure 13 – Worst Case, Mixed-Face Locations

The East River and North River Tunnel geologic pass-through records and inundation conditions were reviewed to identify the “worst case” mixed-faced conditions. The worst case conditions were identified to be in East River Tunnel, Line 1, at the four locations shown in Figure 13. At these locations, the tubes had their maximum inundation levels and spring lines in a mixed-face condition. Since these conditions are all similar, only one analysis was required to determine the increased stress condition.

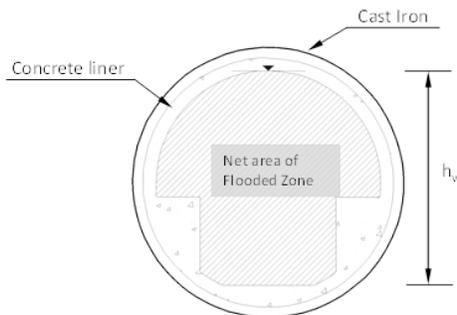
Figure 16 - Net Area Used to Calculate Inundation Loading

The subgrade spring coefficients were derived from the elastic modulus of the support materials. The inundation loading corresponded directly to the level of sea water within the tunnel, Figure 16. For the worst case condition, this corresponds to the mid-river region of the East River Tunnel, which was inundated to the crown, in Lines 1 and 2. Note that the water level in the North River Tunnel was less severe with water reaching above the level of the bench walls. In the East River Tunnel, the sea water

level reached the crowns of the tubes. The net increase in load on the tunnels was calculated based on the area of tube filled multiplied by the unit weight of sea water, 64 pounds per cubic foot.

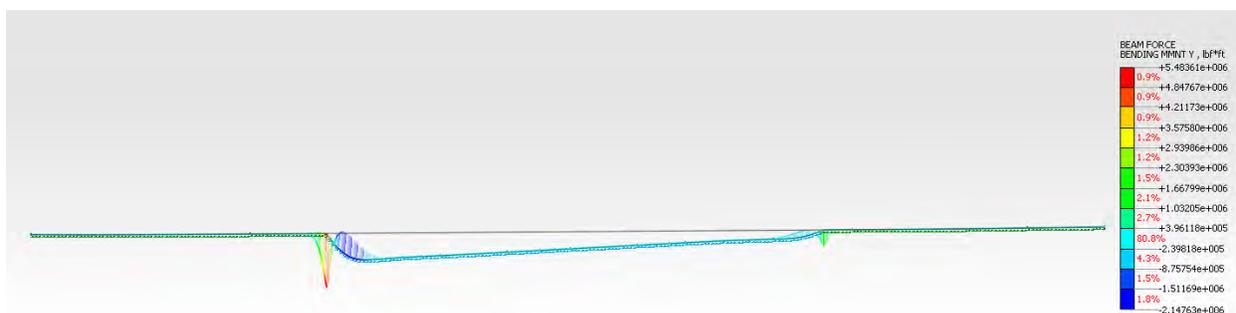
Figure 17 – Resulting Bending Moment in Lining

Deflection analyses were performed using the tube properties, seawater loading, and a range of subgrade properties. Since geotechnical testing of the in-situ soils was not possible for this assessment, a range of properties was analyzed to assess the sensitivity of the tubes to this loading. Of these analyses, the critical loading corresponds to the bending moment. Figure 17 presents the results of one of the cases analyzed.

Increases in bending moment directly impact the stresses in the lining bolts. As the tube deflects downward under the weight of the sea water it rotates on the rock subgrade. This causes the crown of the tunnel to undergo increased tension and the tunnel invert to undergo increased compression. The tunnel's compressive capacity is significant with the combination of the full cast iron and concrete sections available to resist the increased compression. The tube's tensile capacity is not as robust; since the concrete linings in the East River Tunnel are not reinforced and the lining has numerous "cold joints", the tension is resisted solely by the bolts in the cast iron lining.
